Client: GZJMS charity.

Title of Project: Architectural Feasibility Study for the Renovation & Construction of the Existing Facility of the Ekumfi Atwea Primary & J.H.S School.

Location: Ekumfi Atwea, Mfantseman district, Central Region.

Consultants: Dez-intell Workstation (design, build, renovate, Landscape)

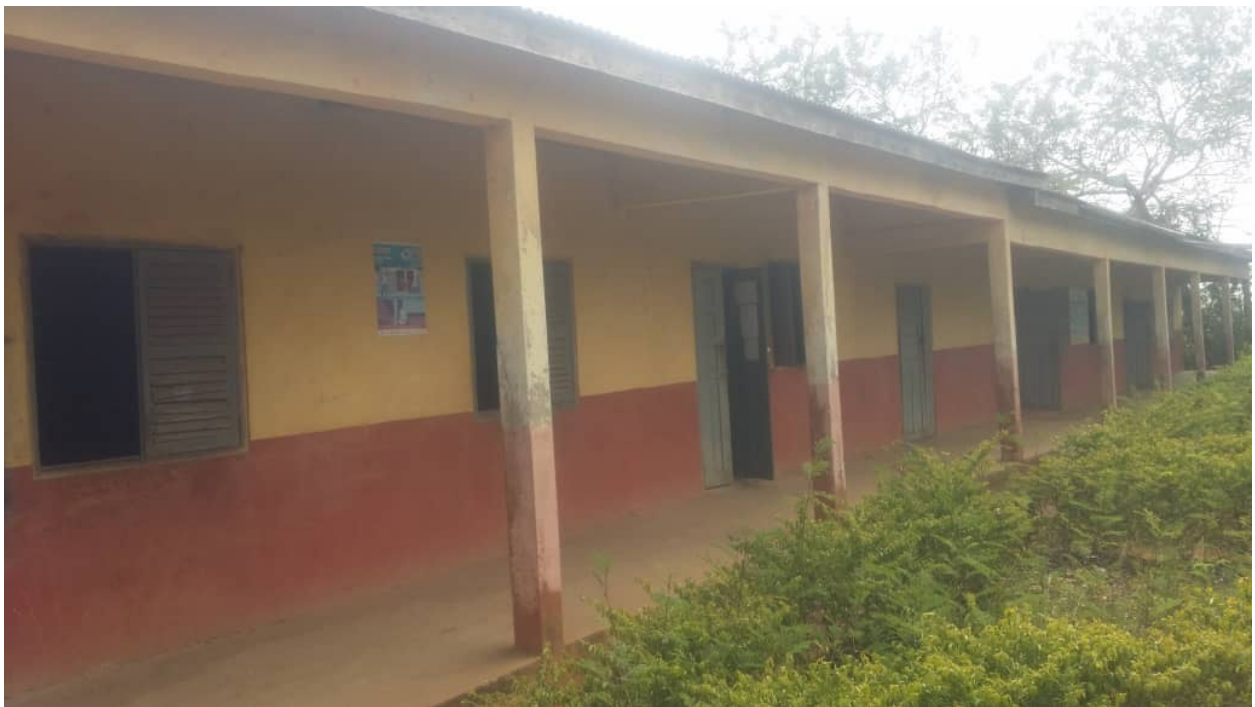
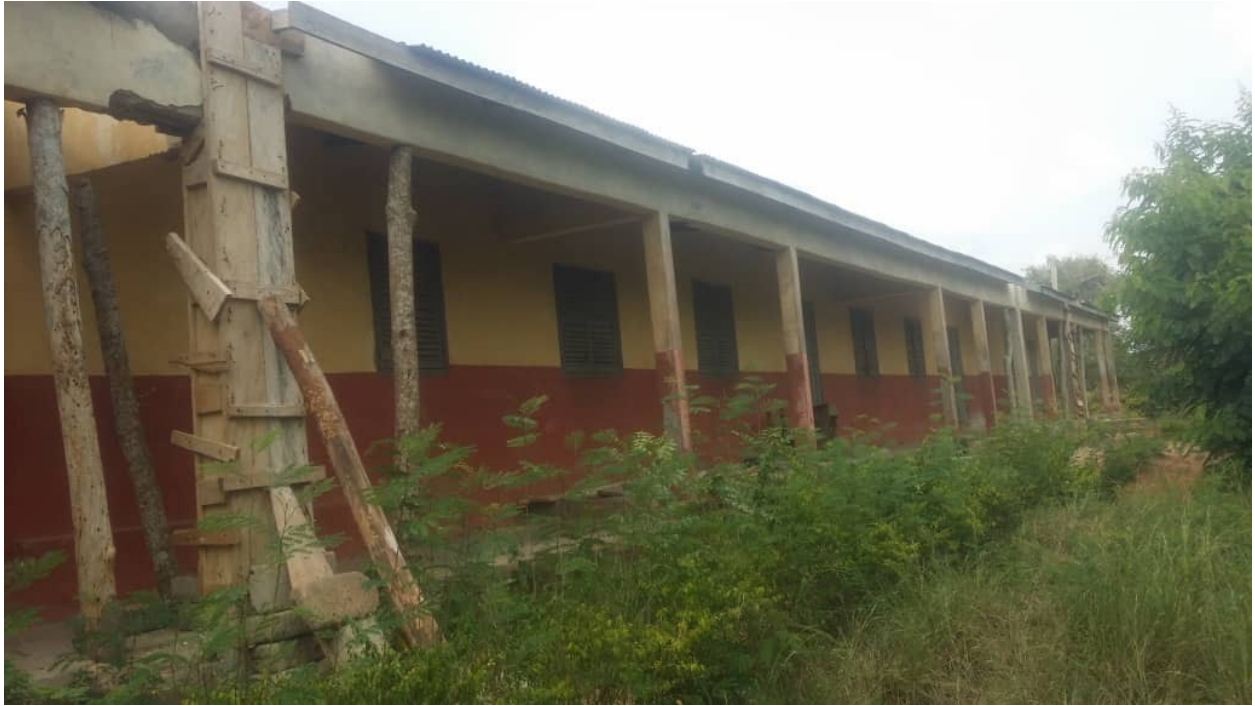
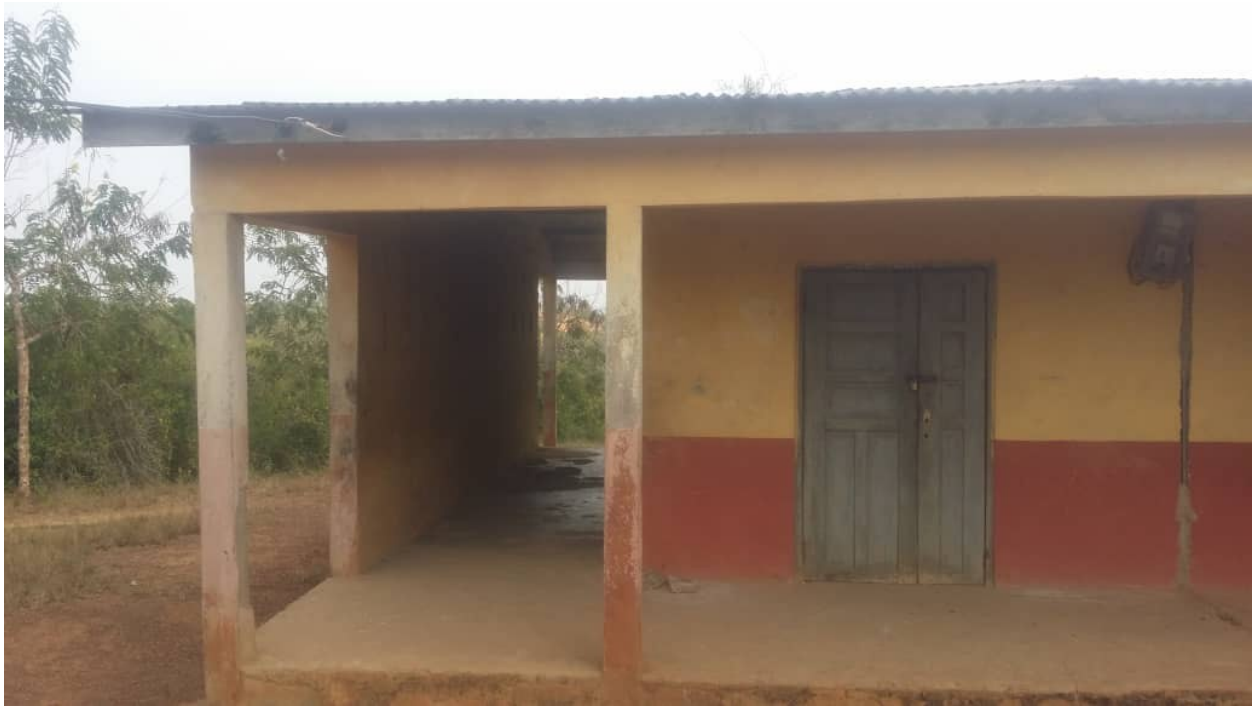
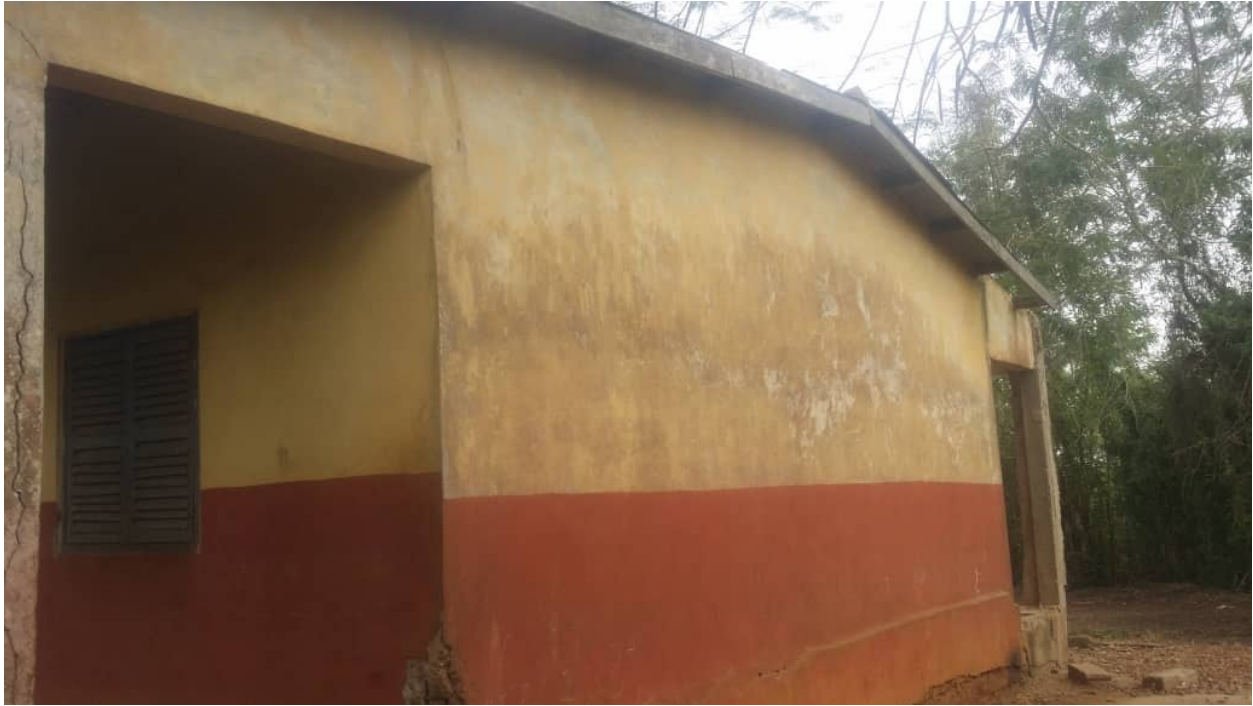
CLASSROOM BLOCK (A)

With regards to the above structure which represents block A in the alphabetical order. There are serious of structural defects regarding columns with iron rods sticking out and wearing off, with serious cracks within the walls of the existing structure. Some of the columns have been replaced or supported with tree trunks so as to support the roof from caving in. Furthermore, beams sitting on these columns have not been spared either by these defects as some have been temporarily re-enforced as with

parts of the walls chipped off with the floor of the building chipping off as well.

With regards to portions of the wooden members holding the Roof of this particular block (A), parts of it are rotten, with major trusses bending with the roof caving in.

The discolored asbestos roofing sheets looks weak with cracks and leakages with no ceiling's or fixed eaves. Fascia boards are all worn out. Some of the roofs have been virtually ripped off due to the weak nature of it leaving the building at the messy of the weather.

Most door frames, as well as window frames are rotten due to roof leakages.

Finally the entire existing structure lacks painting which contributes to the aesthetics of the structure.

- a) Columns and beams with cracks and iron rods sticking out must be demolished, reinforced and reconstructed.
- b) Walls with major cracks must be demolished and reconstructed.
- c) The floors must be repaired and given a smooth masonry finish.
- d) Some of the Wooden members holding the roof must be replaced, weak trusses, including ceiling hangers as well as fascia boards and eaves must be fixed and replaced.
- e) With regards to the entire asbestos roof, we recommend that long span aluminum roofing sheets be used, instead of the asbestos, as most of the slate roof looks very fragile and may collapse and cause serious damage.
- f) Most of the doors and window frames need replacement under our assessment.

- g) Finally the entire structure needs painting, which will enhance the aesthetics of the structure.

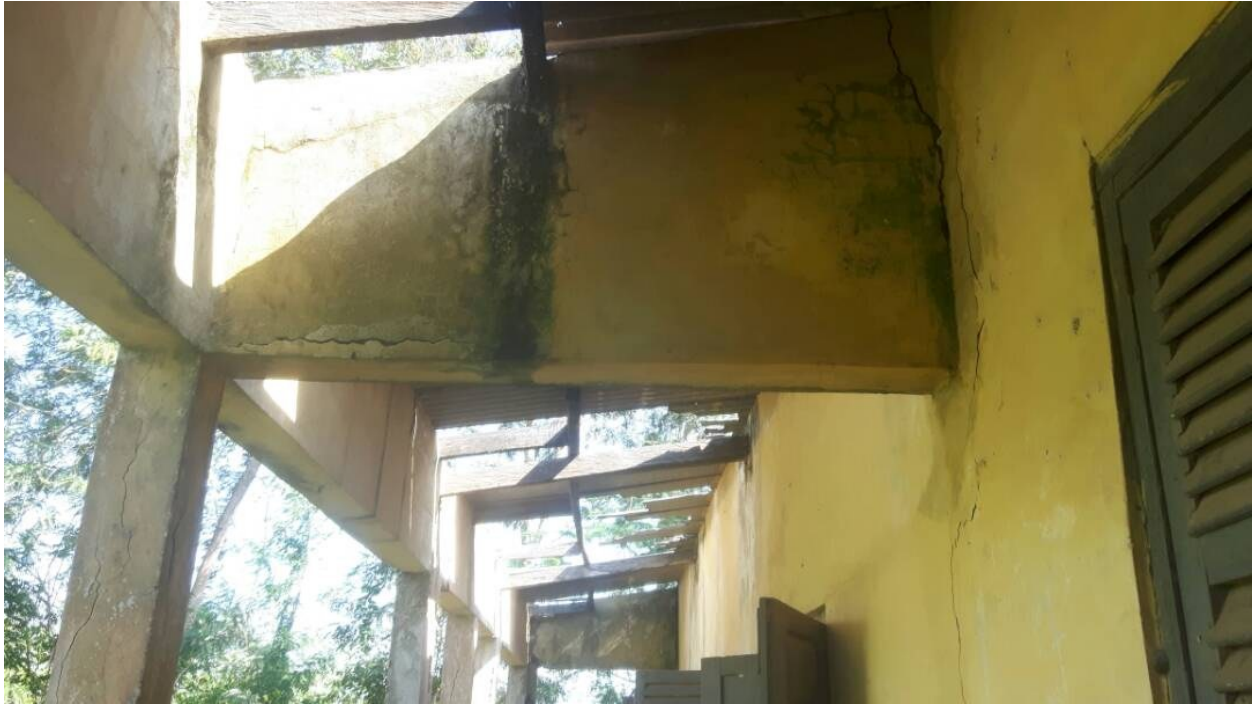
Due to these defects the walls have been discolored leaving portions of the walls greenish.

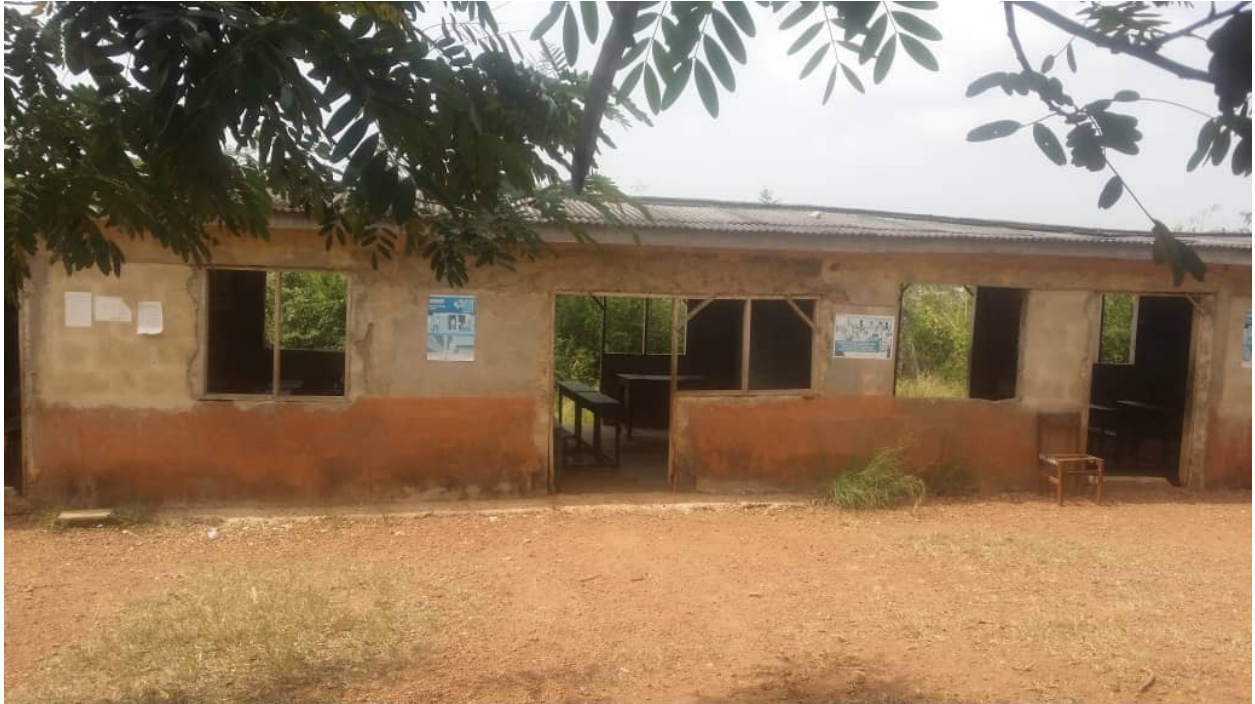
CLASSROOM BLOCK (B)

The classroom block (B) Above happens to be the Primary block of the Ekumfi, Atwea school, Which comprises of 3 three classrooms within this block. The floor of the entire block is below ground level, as the foundation of the block was not raised to the standard foundation level of our

building code specifications. This may cause Sand/debris within the classrooms, and also create floods within the classrooms

The classrooms do not have windows, since the safety of the children is at stake when it rains.

Furthermore the classrooms do not have ceilings within, as this may cause the roof to expel heat during the day time whilst the children may be in the classroom.

- a) The floor of this existing structure must be raised to the standard floor level of the building code specifications.
- b) Major cracks and gradient of the roof must be raised so as to prevent leakages.
- c) All masonry works must be fixed.
- d) Parts of the wooden members need to be replaced as some looks weak.

- e) The entire classrooms require plywood ceilings so as to reduce the amount of heat that is released during the day time.
- f) Again doors and windows must be fixed to secure the safety of the structure.
- g) The entire roof also must be replaced with the long span aluminum roofing sheets since the asbestos roofing sheets looks fragile or weak.

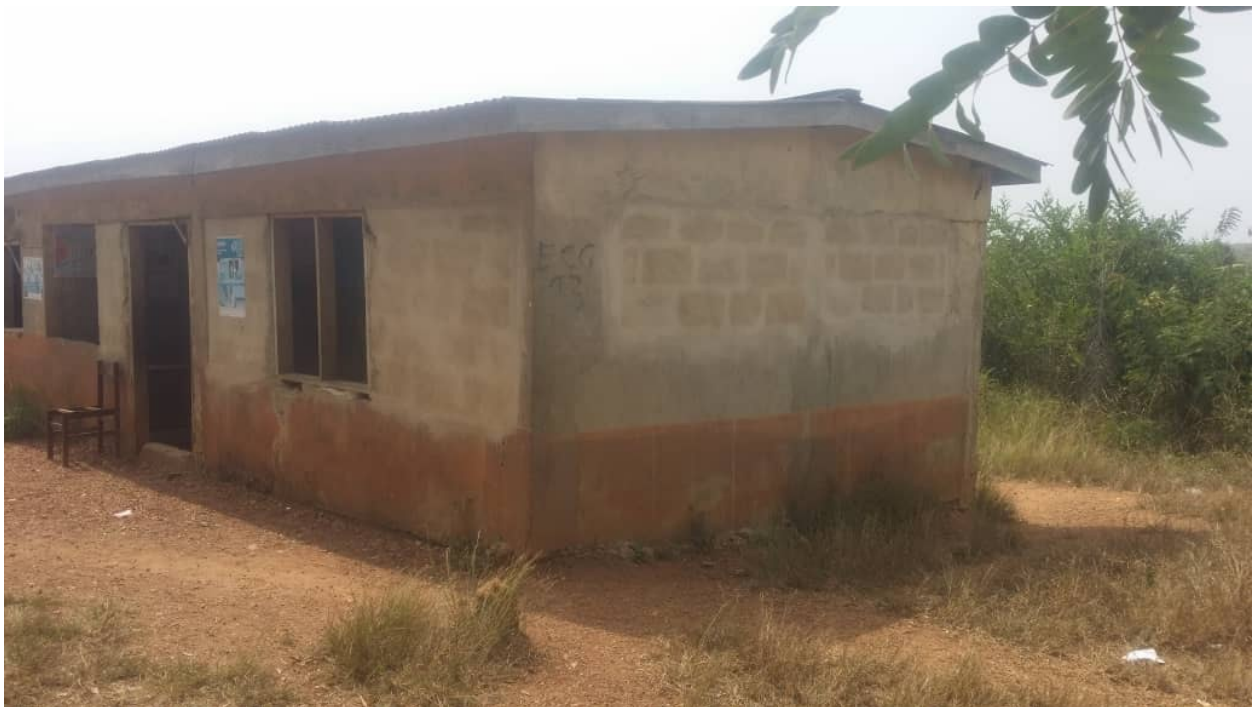
Window frames of the existing structure upon our assessment needs to be replaced due to its weak state.

Also some wooden roofing members need to be replaced as this is causing the roof to cave in, as this is extremely dangerous. Finally there are only doors and window frames, even not all as shown in the pictures and not a single door and window is being fixed.

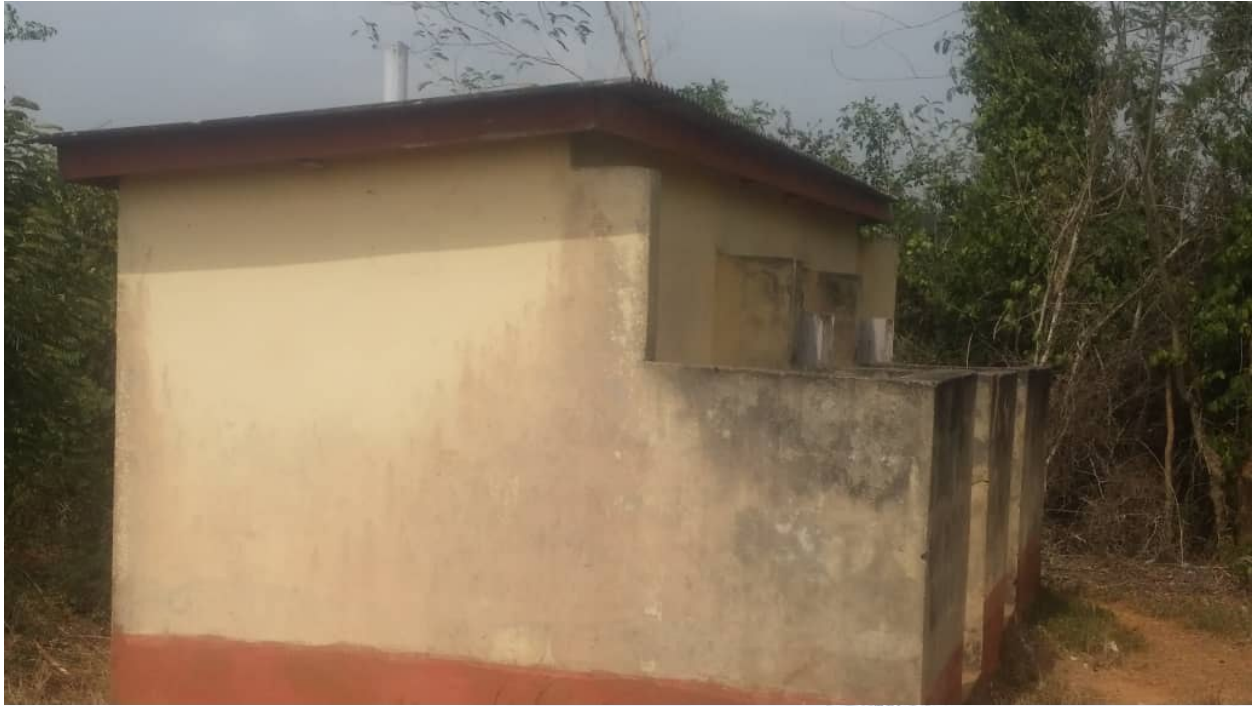
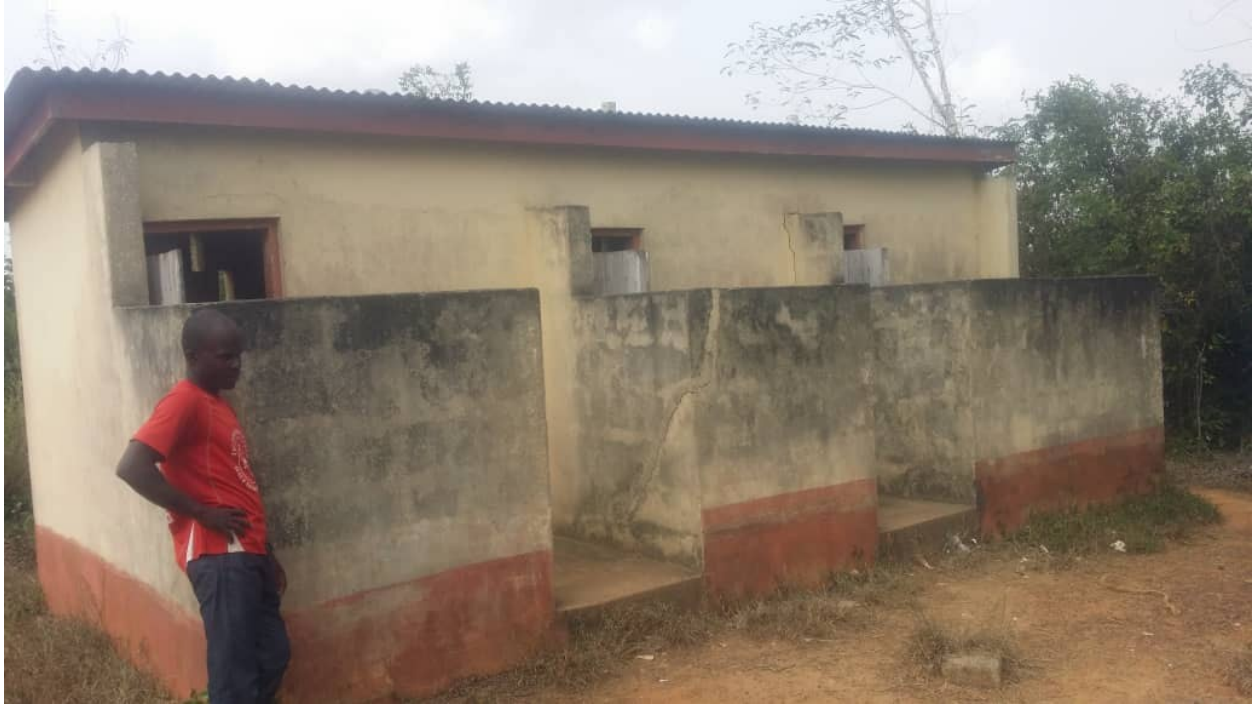
TRADITIONAL PIT LATRINE

The above picture block (C) shows a traditional pit latrine which is being used by the school pupils and authorities. This is an old fashioned

toilet facility which is outdated and not hygienic and it's an open facility due to its structure creates bad odour within the school environment and may cause an epidemic like cholera and other diseases. This is being used because the school is not connected to the main service line of the GWCL (Ghana Water Company limited) Furthermore the structure happens to be close to the kitchen of the school feeding Facility.

Also the facility may not be safe due to its open design and may harbor dangerous animals like reptiles and so forth.

This traditional toilet facility, which has been used by the school over a no. of years, needs to be replaced.

Our recommendations, regarding this structure is that since it's a traditional pit latrine, it needs to be replaced by a modern toilet facility. The structure lacks hygienic principles within the school and due to its size, lacks the ability to accommodate the

no. of pupils using the facility. Therefore a modern spacious toilet facility may be required, designed, constructed so as to reduce the burden of the no. of pupils and authorities using the facility.

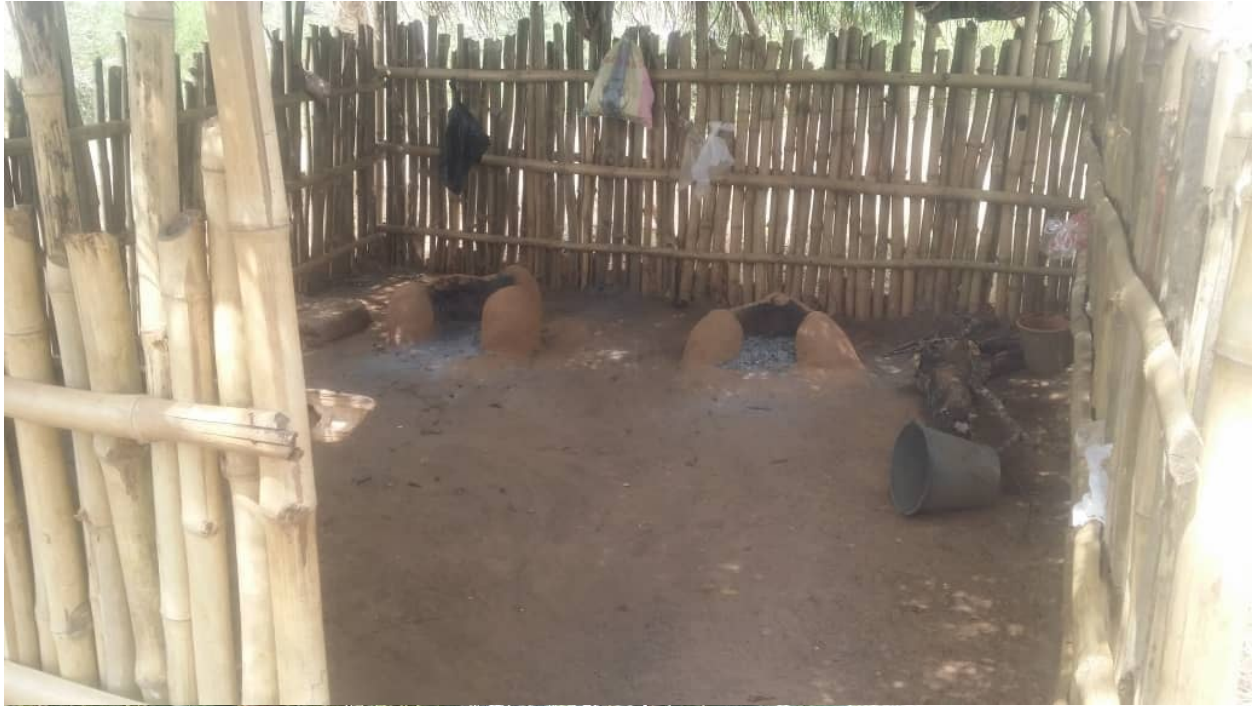
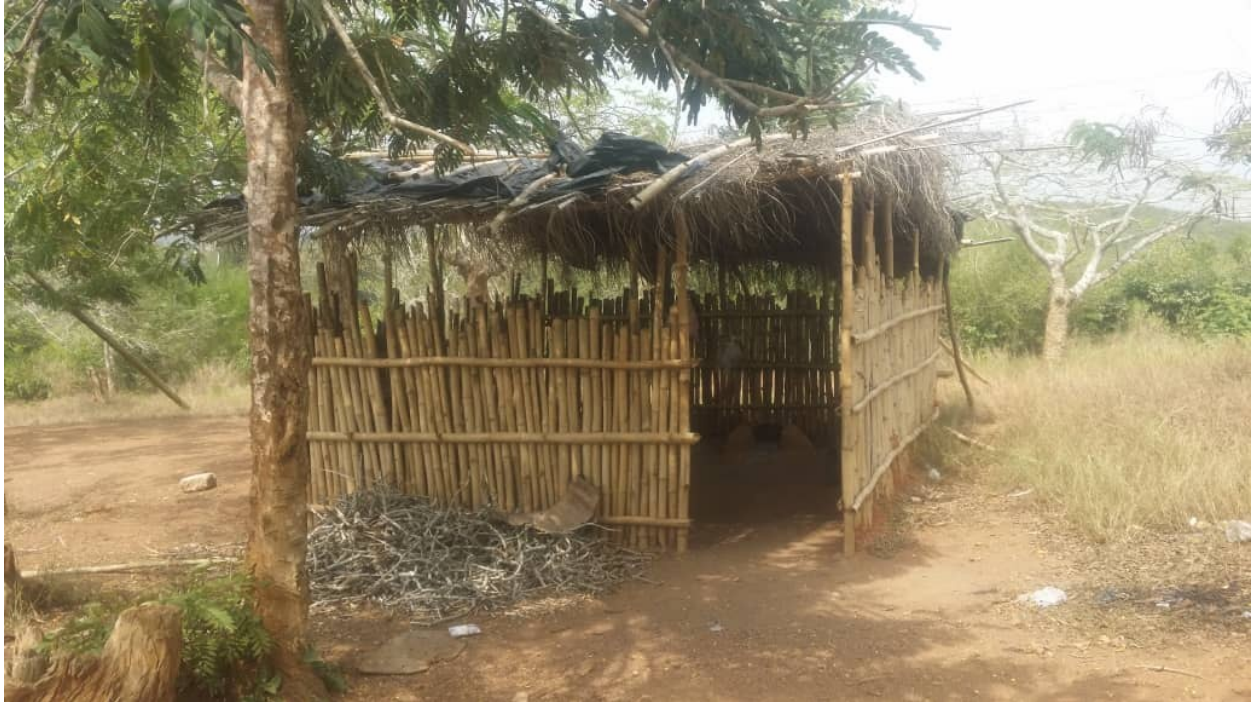
TEMPORAL EXISTING STRUCTURE (D)

The above picture happens to be a temporal structure that houses the caterers under the

school feeding program. This Structure is made of Bamboo and thatched roof which does not make it a secure place to house the caterers.

Furthermore the structure only has the traditional clay cooking unit with no work tops, not secured and also does not look hygienic.

The Temporal existing structure which is being used by the caterers under the school feeding program needs to be replaced by a modern facility. Our recommendations are as follows:

- (a) A modern Facility be provided, designed and constructed which must include a kitchen and a dining area so as to accommodate the caterers and also serve as a dining area for the entire school.
- (b) This facility must have an overhead water reservoir to serve the kitchen and dining to serve the entire facility.
