Client: GZJMS charity.

Title of Project: Architectural Feasibility Study for the Renovation & Construction of the Existing Facility of the Ekumfi Atwea Primary & J.H.S School.

Location: Ekumfi Atwea, Mfantseman district, Central Region.

Consultants: Dez-intell Workstation (design, build, renovate, Landscape)

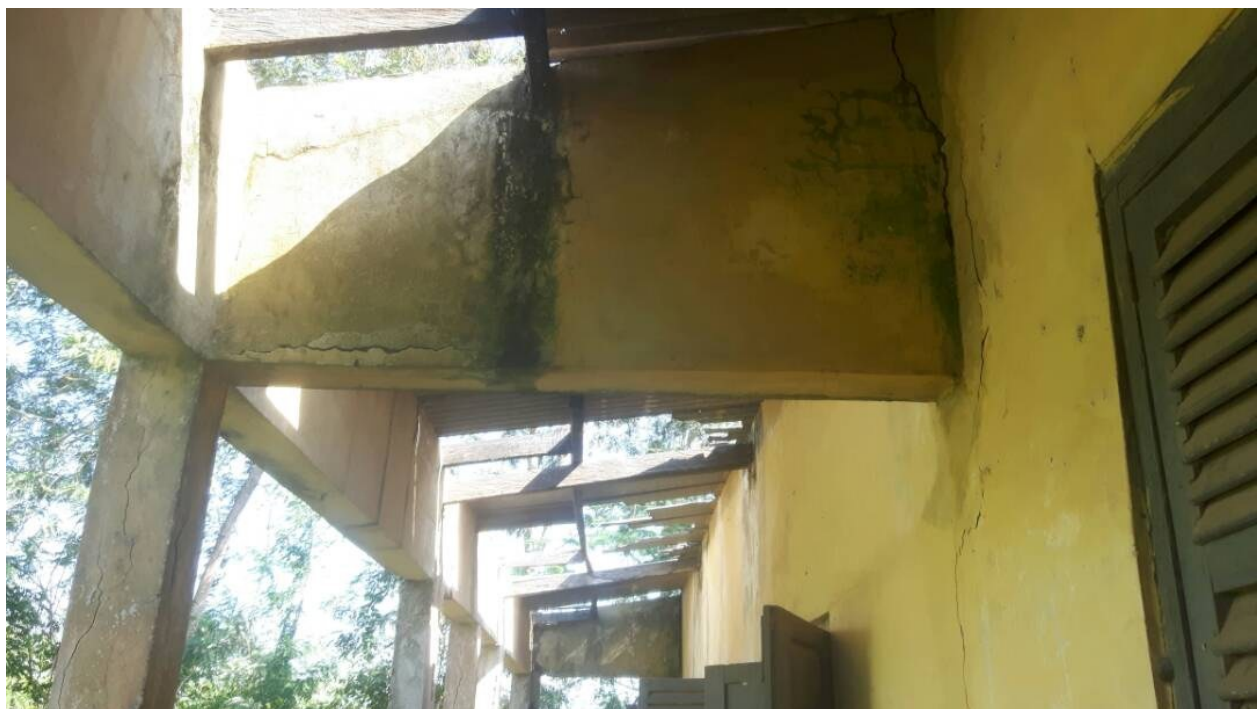
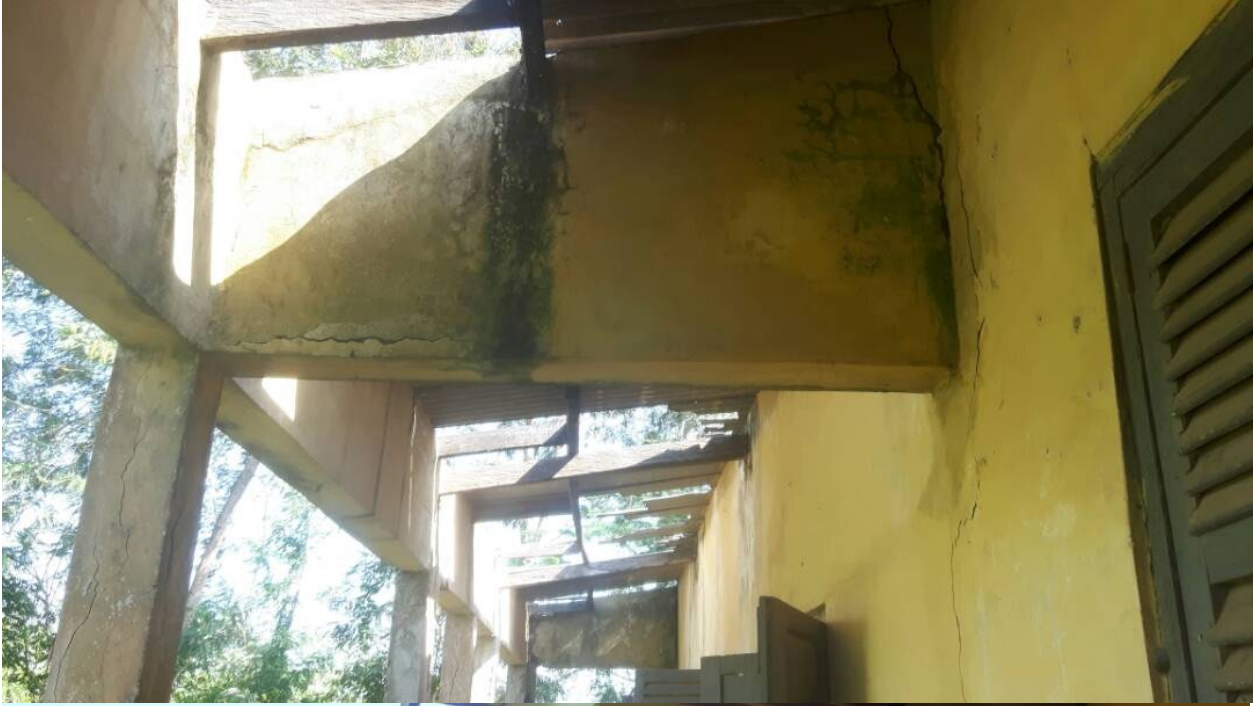
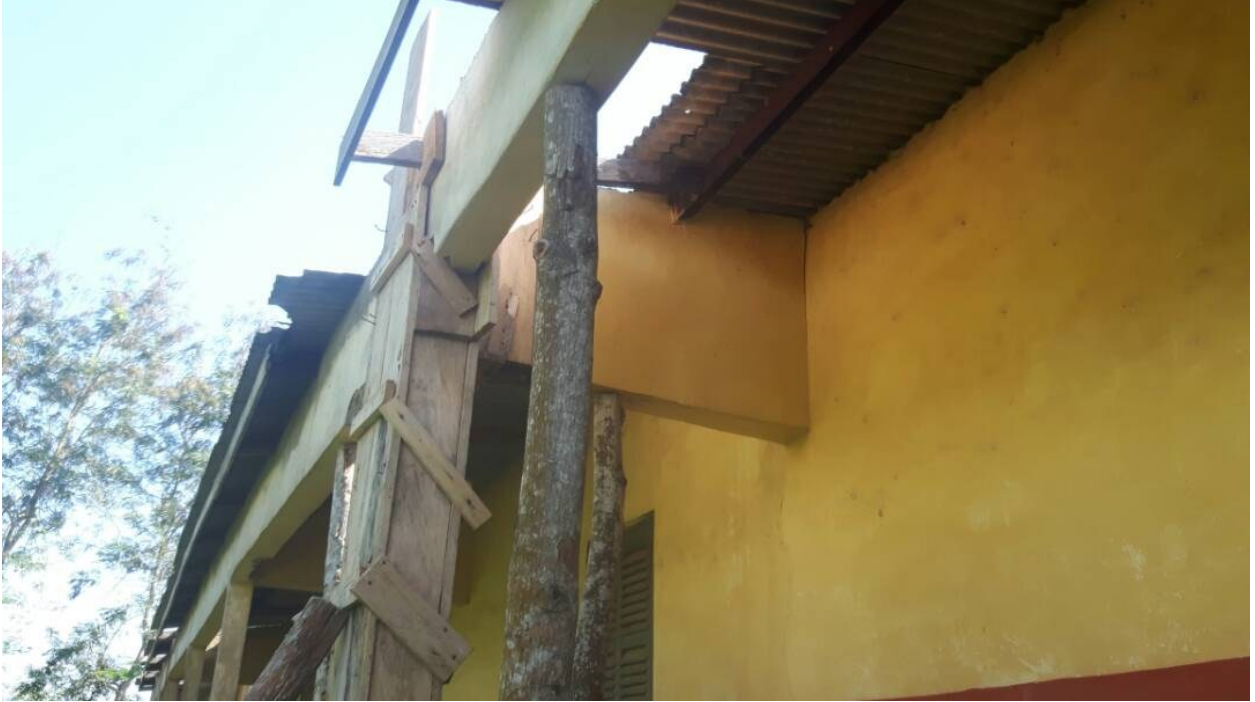
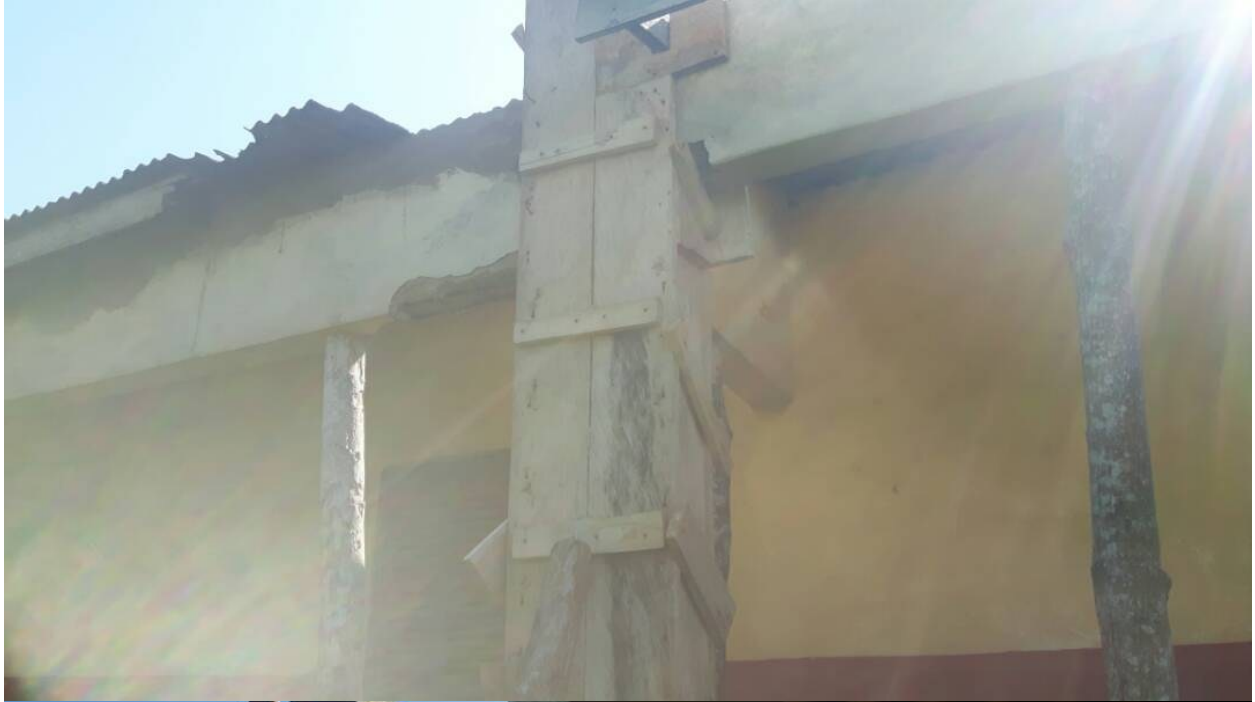
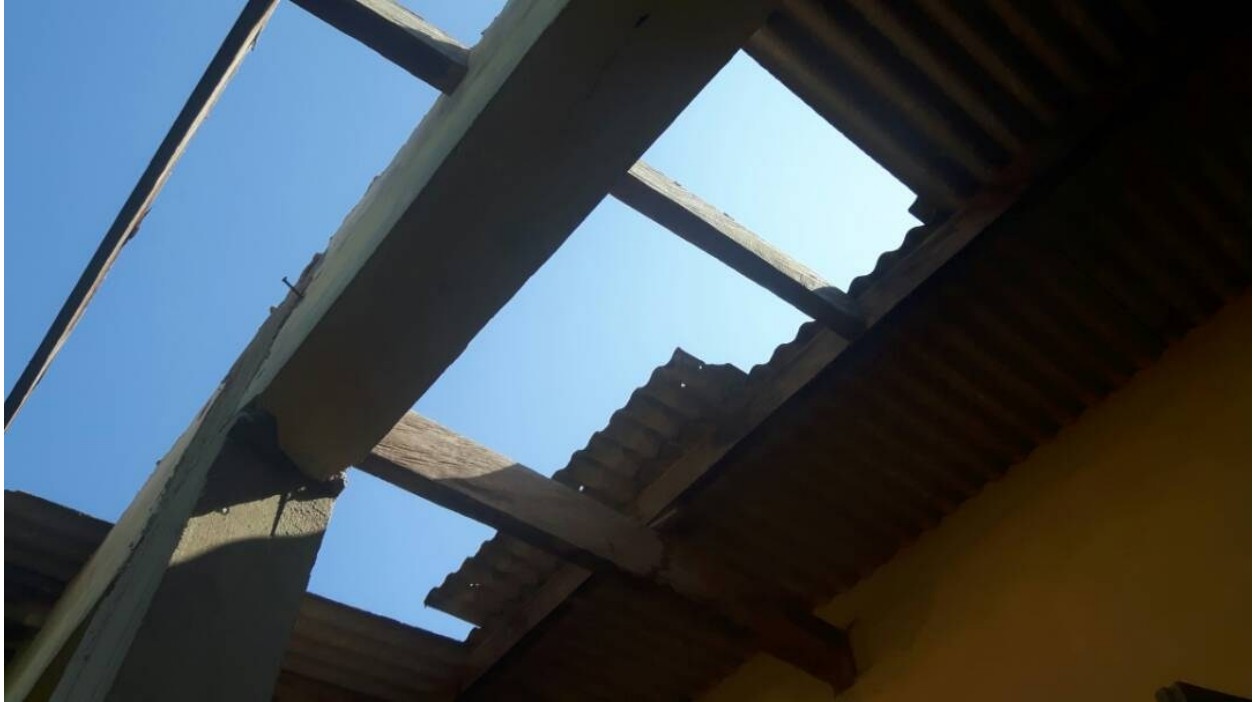
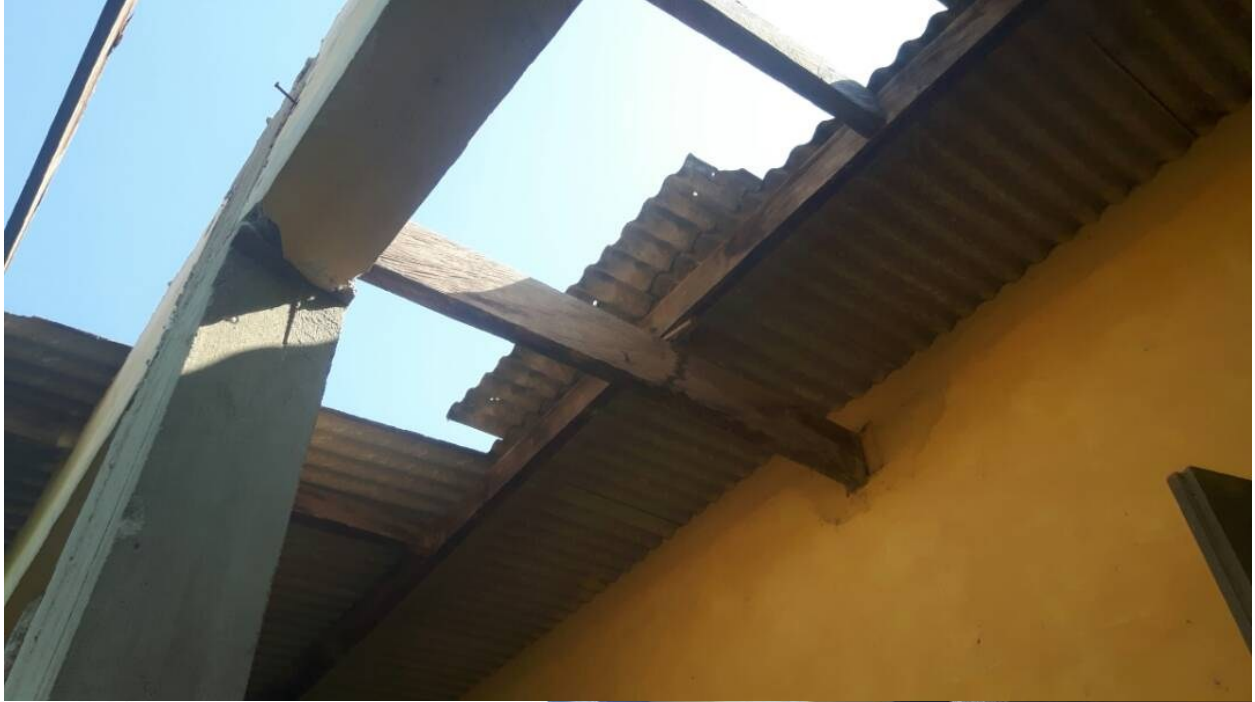
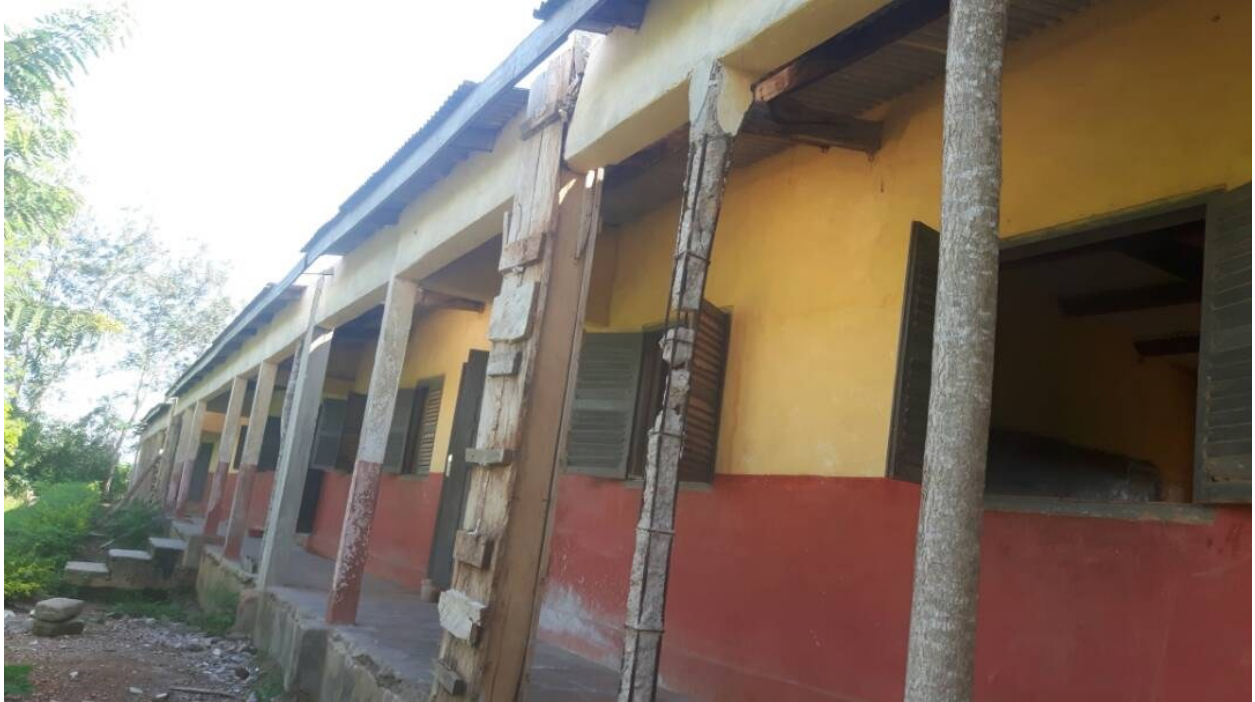
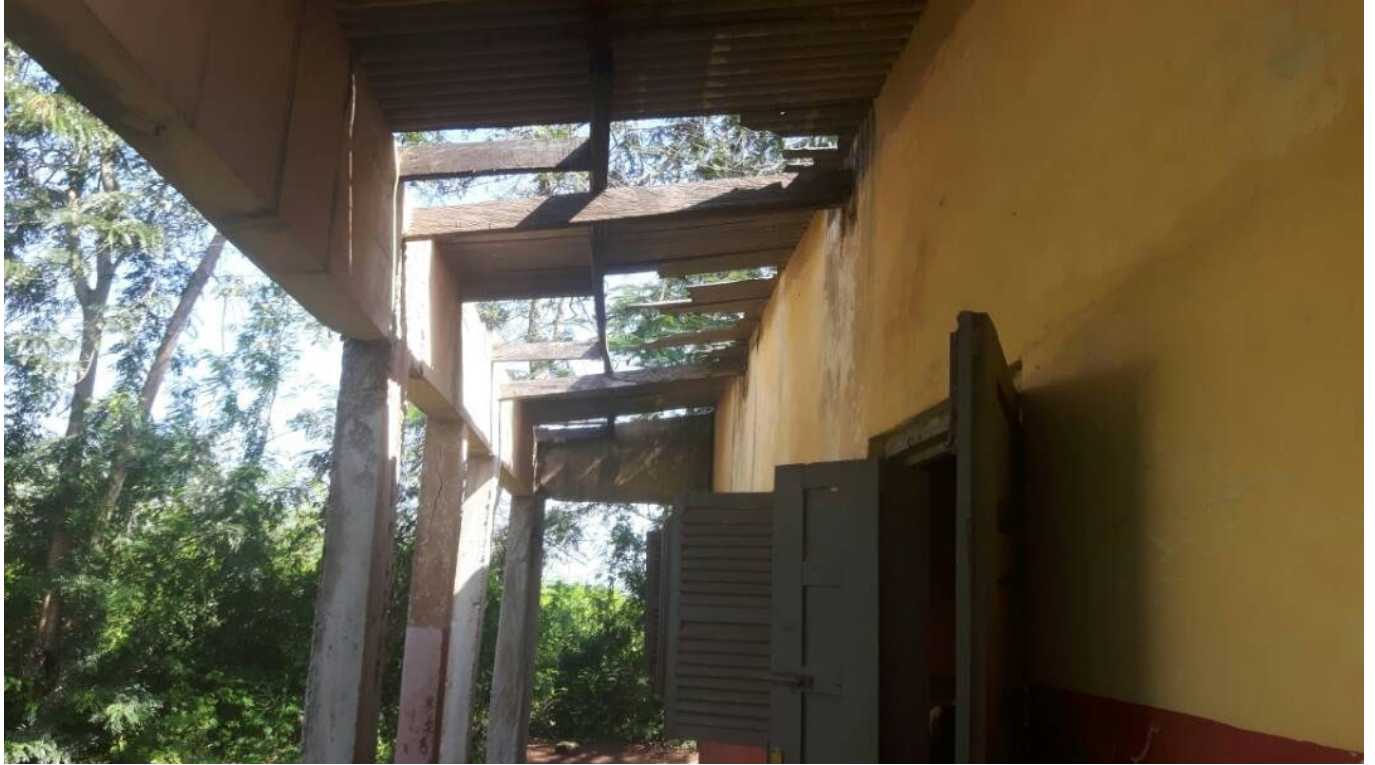
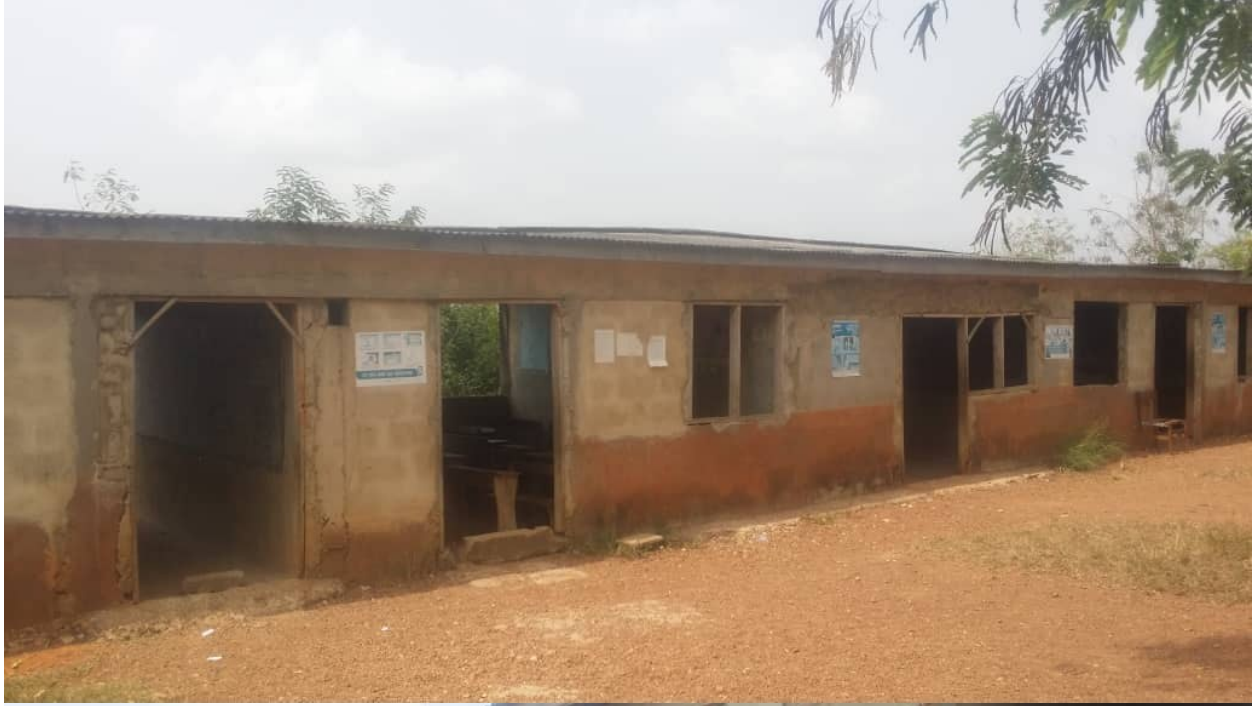
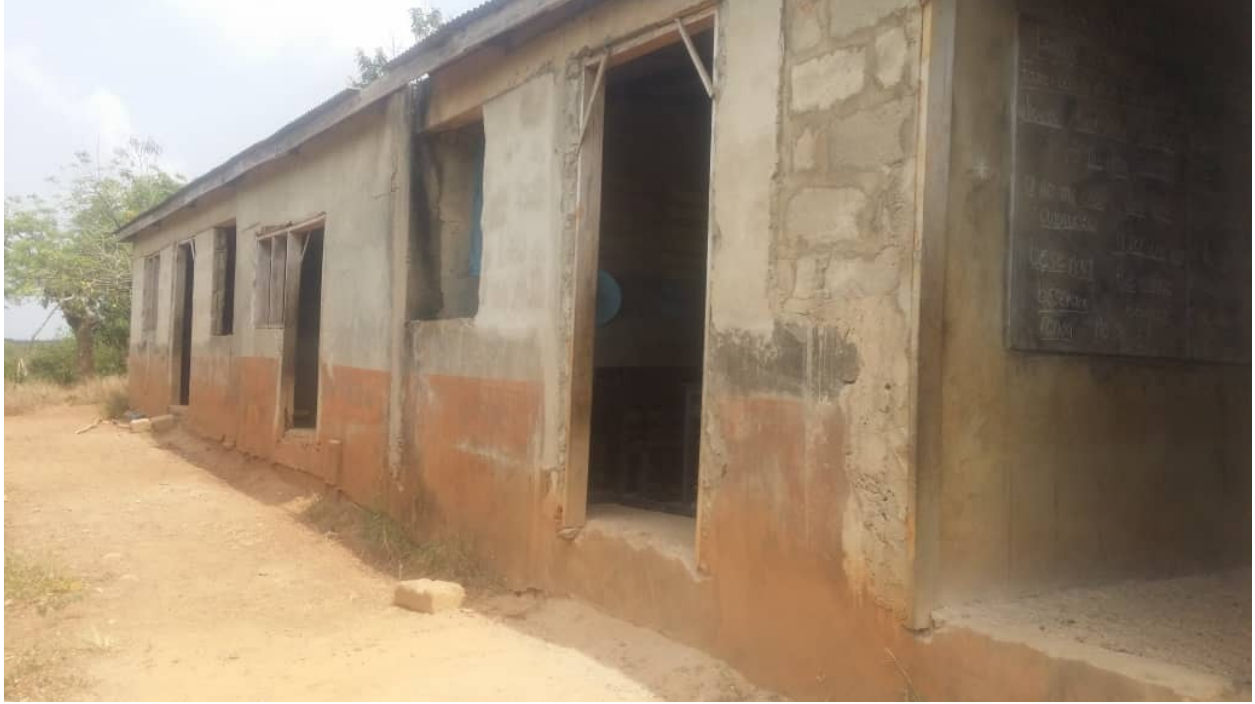
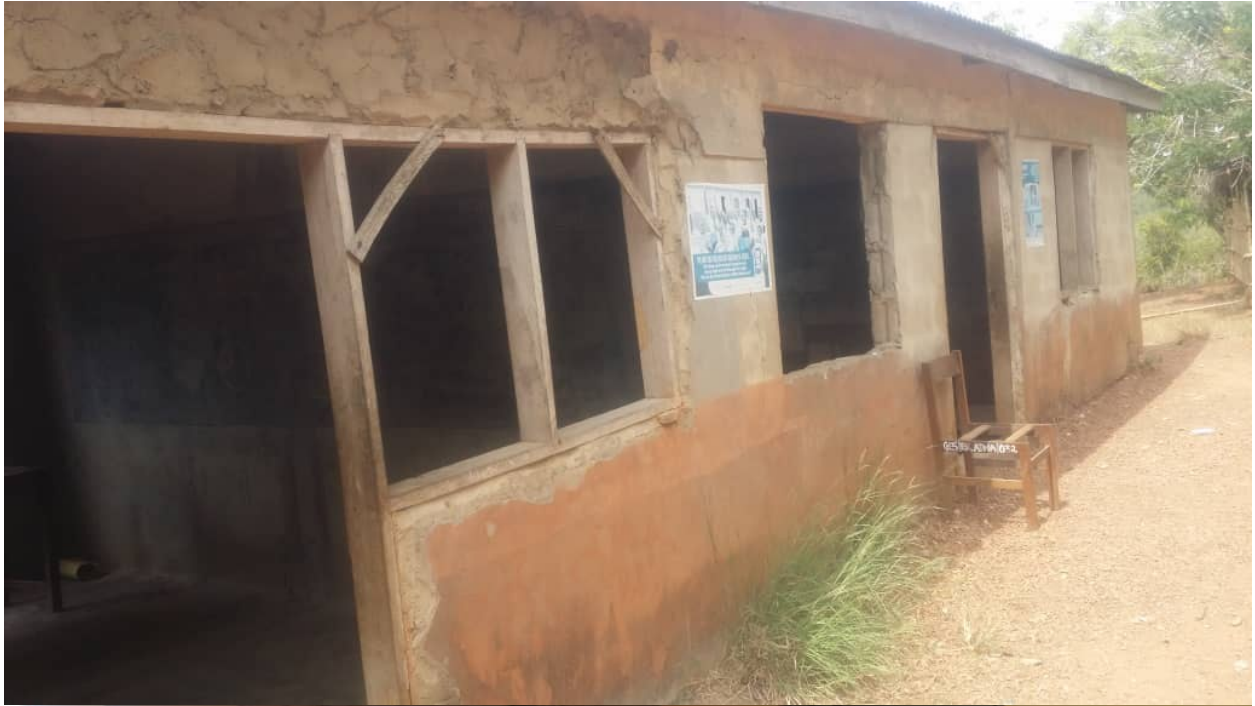
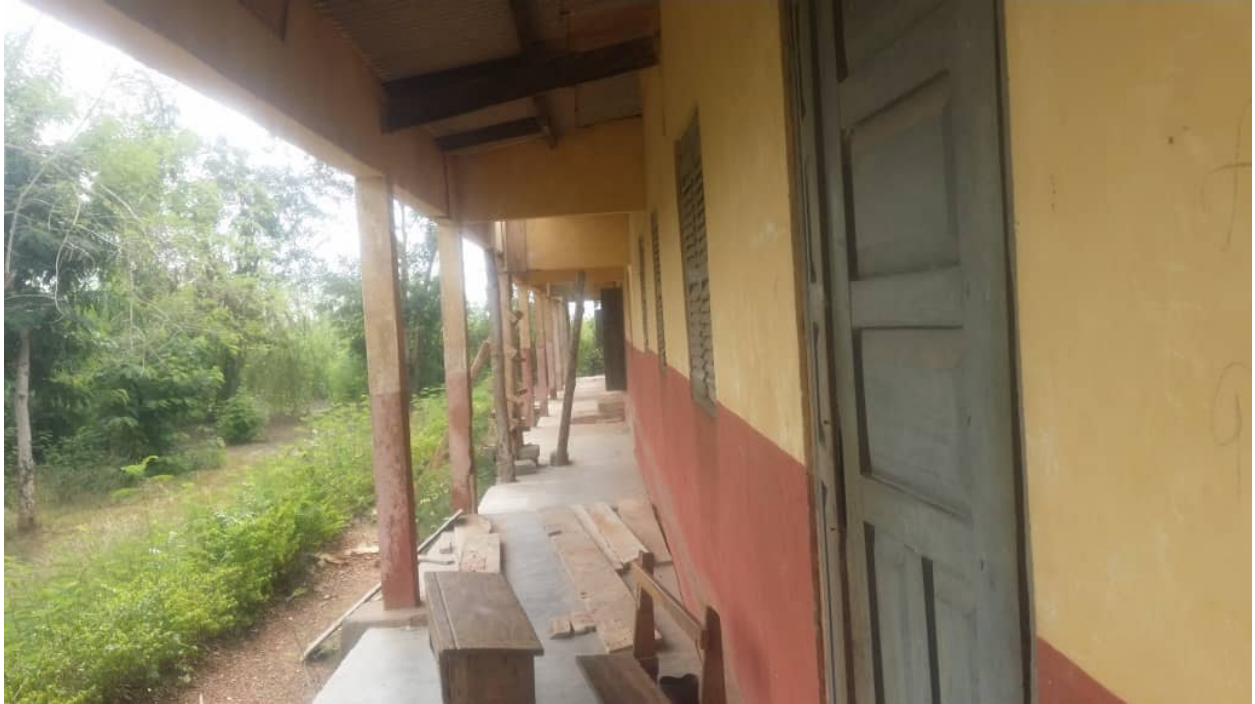
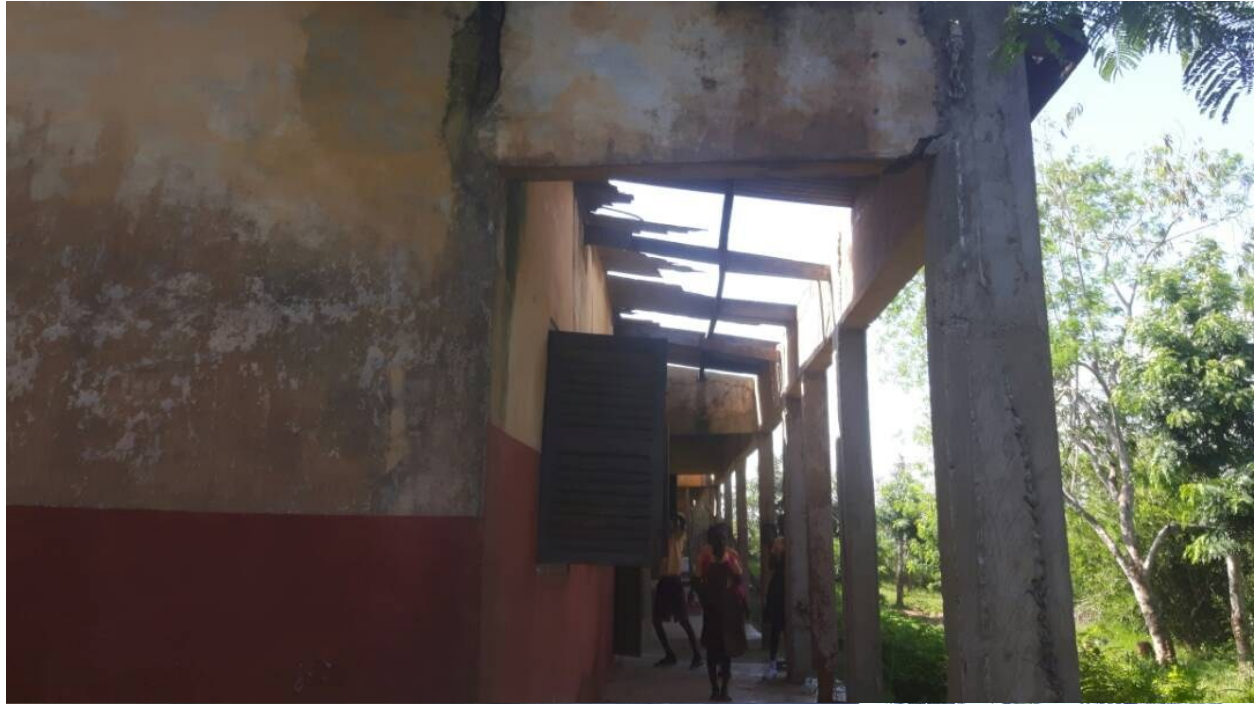
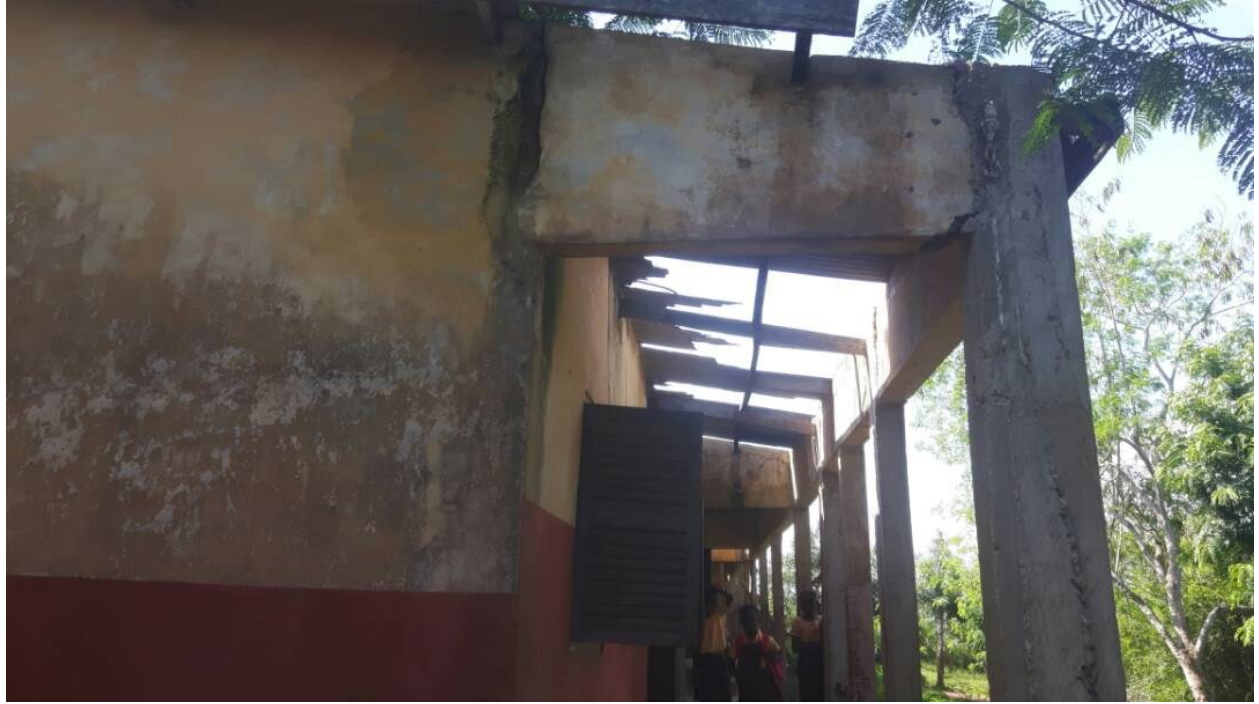
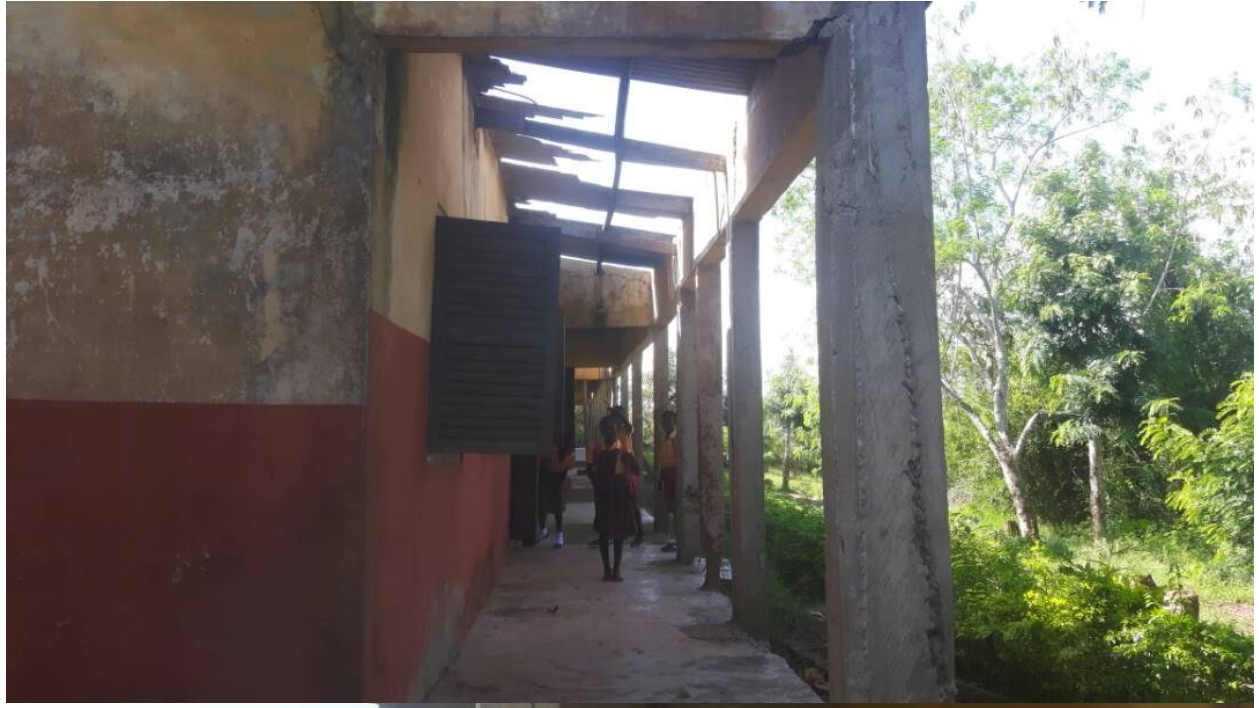
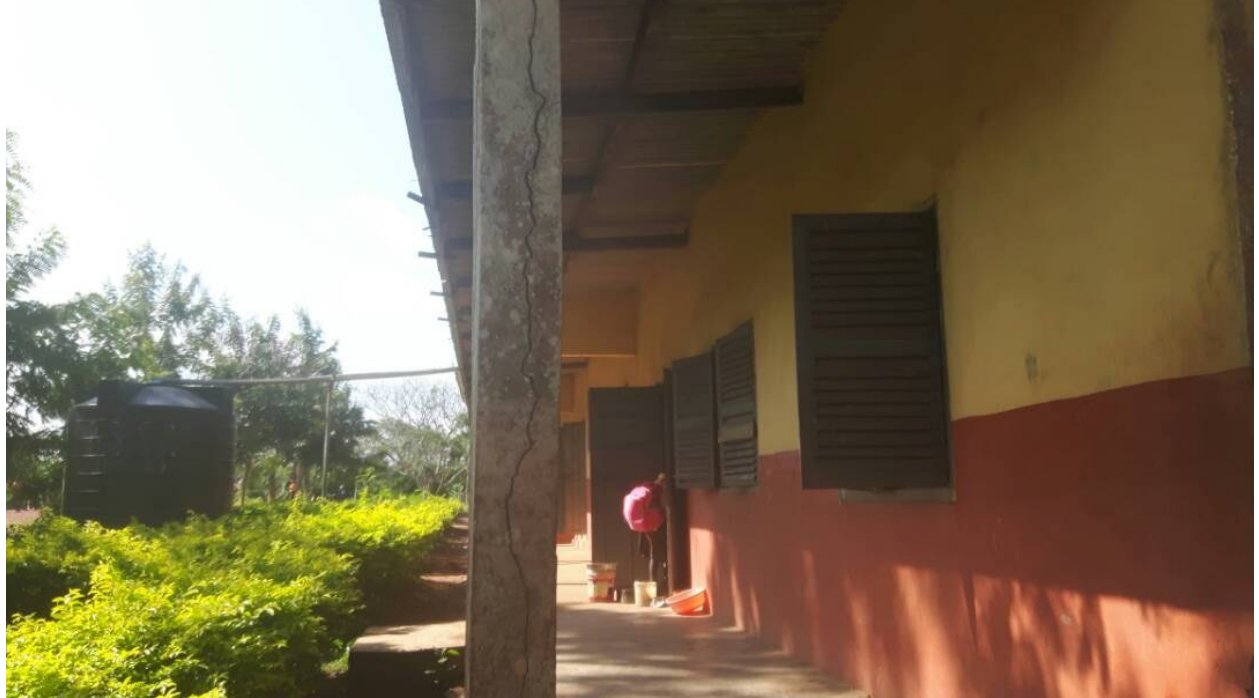
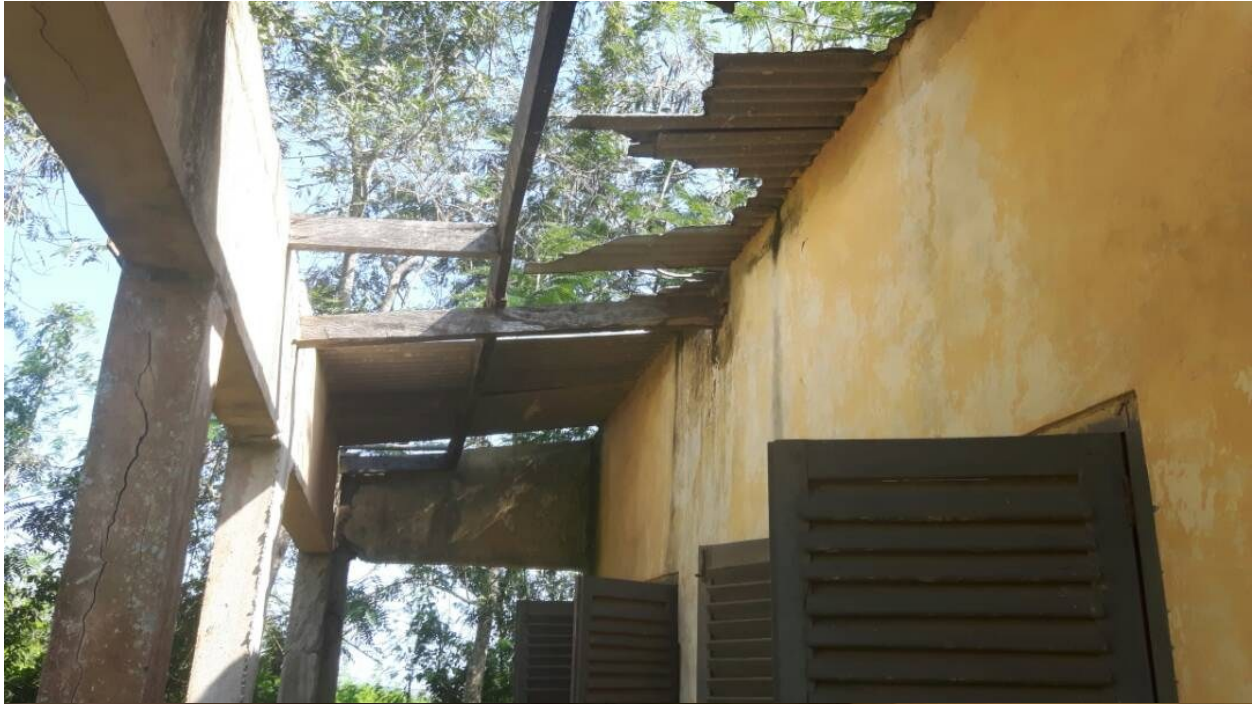
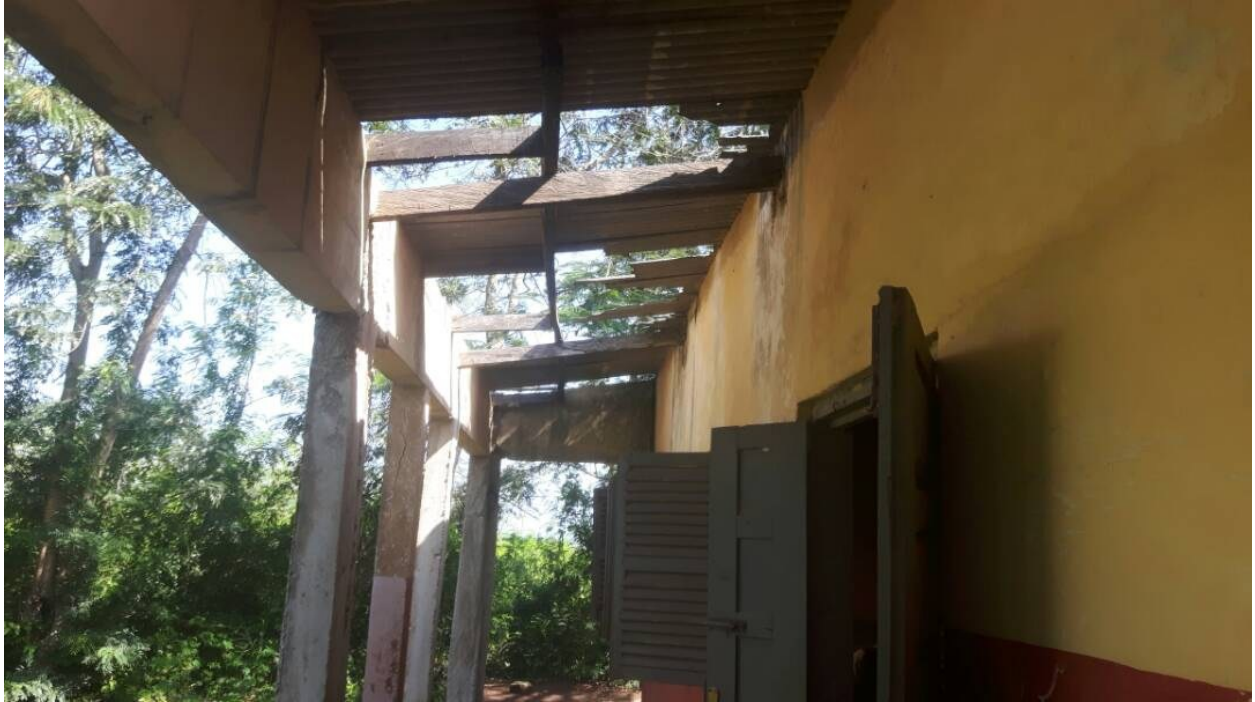
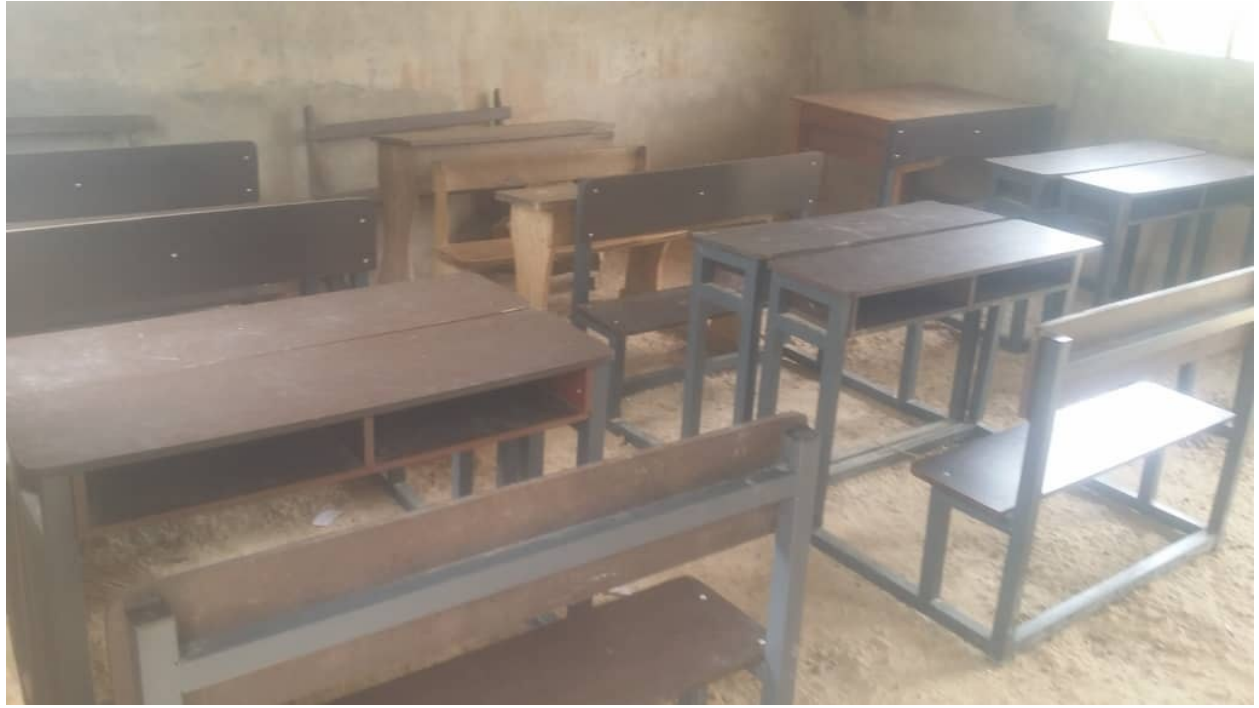
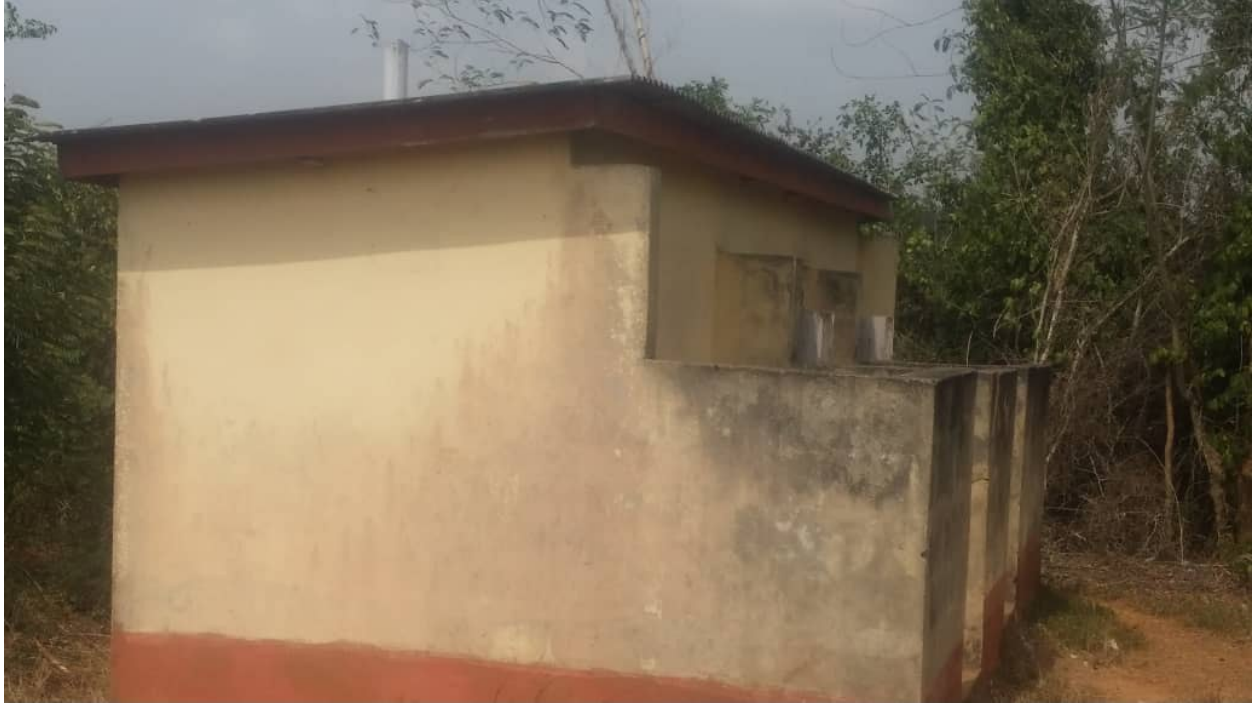
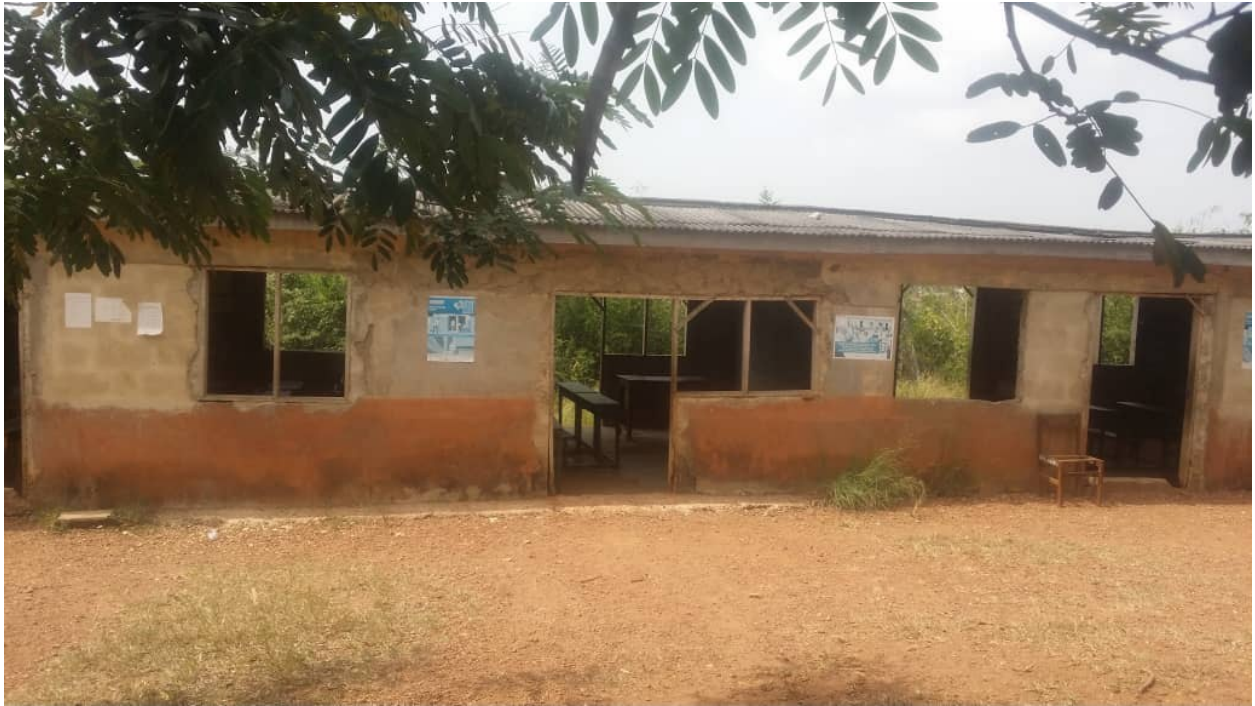
The following picture shows the state of the Ekumfi, Atwea primary & j.h.s School.

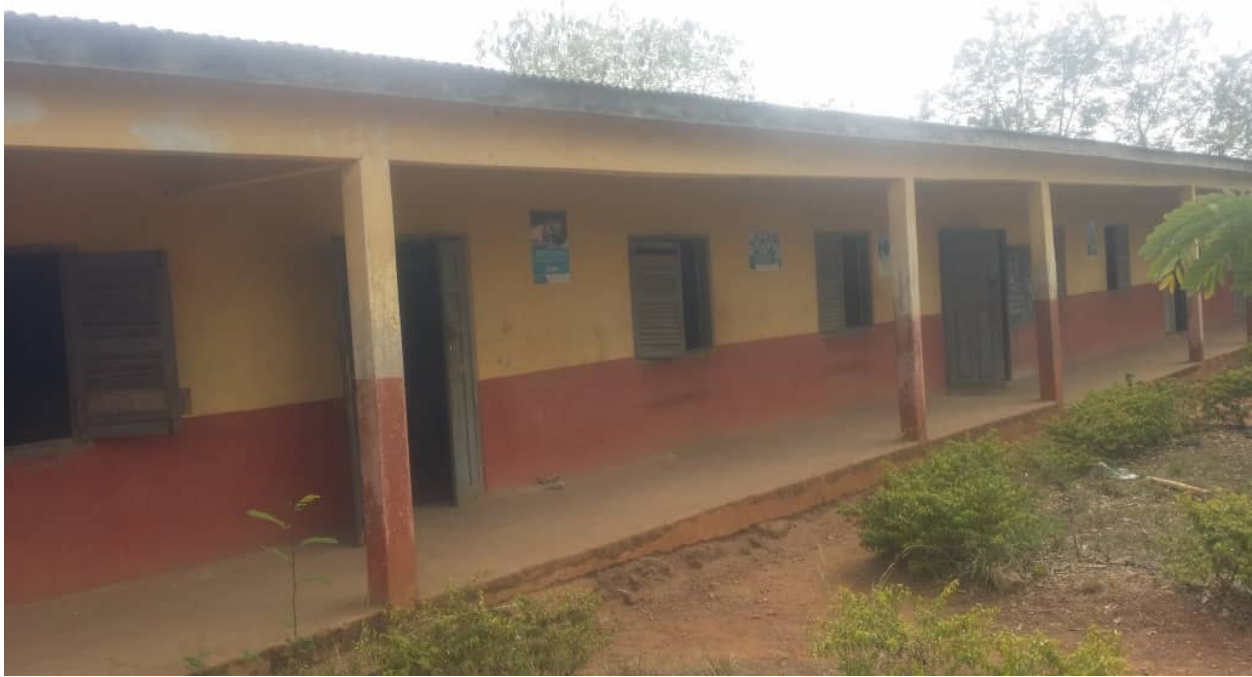
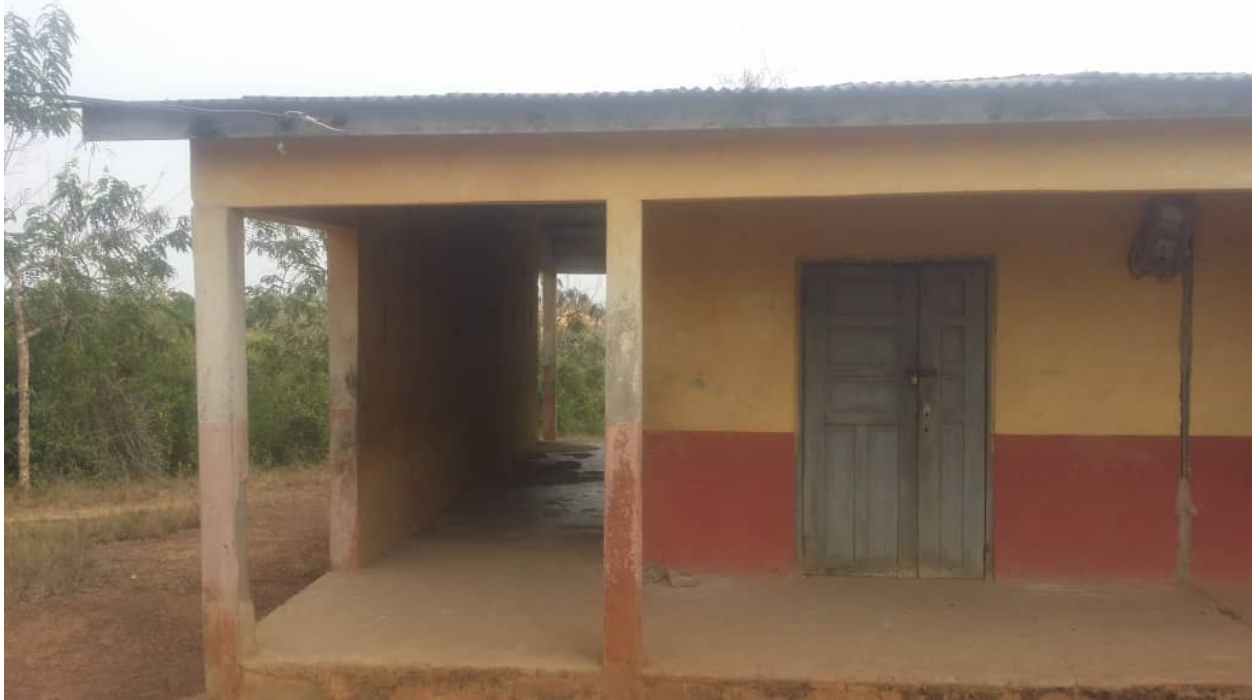
With regards to the above structure which represents block A in the alphabetical order. There are serious of structural defects regarding columns with iron rods sticking out and wearing off, with serious cracks within the walls of the existing structure. Some of the columns have been replaced or supported with tree trunks so as to support the roof from caving in. Furthermore, beams sitting on these columns have not been spared either by these defects as some have been temporarily re-enforced as with

The discolored asbestos roofing sheets looks weak with cracks and leakages with no ceiling's or fixed eaves. Fascia boards are all worn out. Some of the roofs have been virtually ripped off due to the weak nature of it leaving the building at the messy of the weather.

Most door frames, as well as window frames are rotten due to roof leakages.

Due to these defects the walls have been discolored leaving portions of the walls greenish.

- a) Columns and beams with cracks and iron rods sticking out must be demolished, reinforced and reconstructed.
- b) Walls with major cracks must be demolished and reconstructed.
- c) The floors must be repaired and given a smooth masonry finish.
- d) Some of the Wooden members holding the roof must be replaced, weak trusses, including ceiling hangers as well as fascia boards and eaves must be fixed and replaced.
- e) With regards to the entire asbestos roof, we recommend that long span aluminum roofing sheets be used, instead of the asbestos, as most of the slate roof looks very fragile and may collapse and cause serious damage.
- f) Most of the doors and window frames need replacement under our assessment.

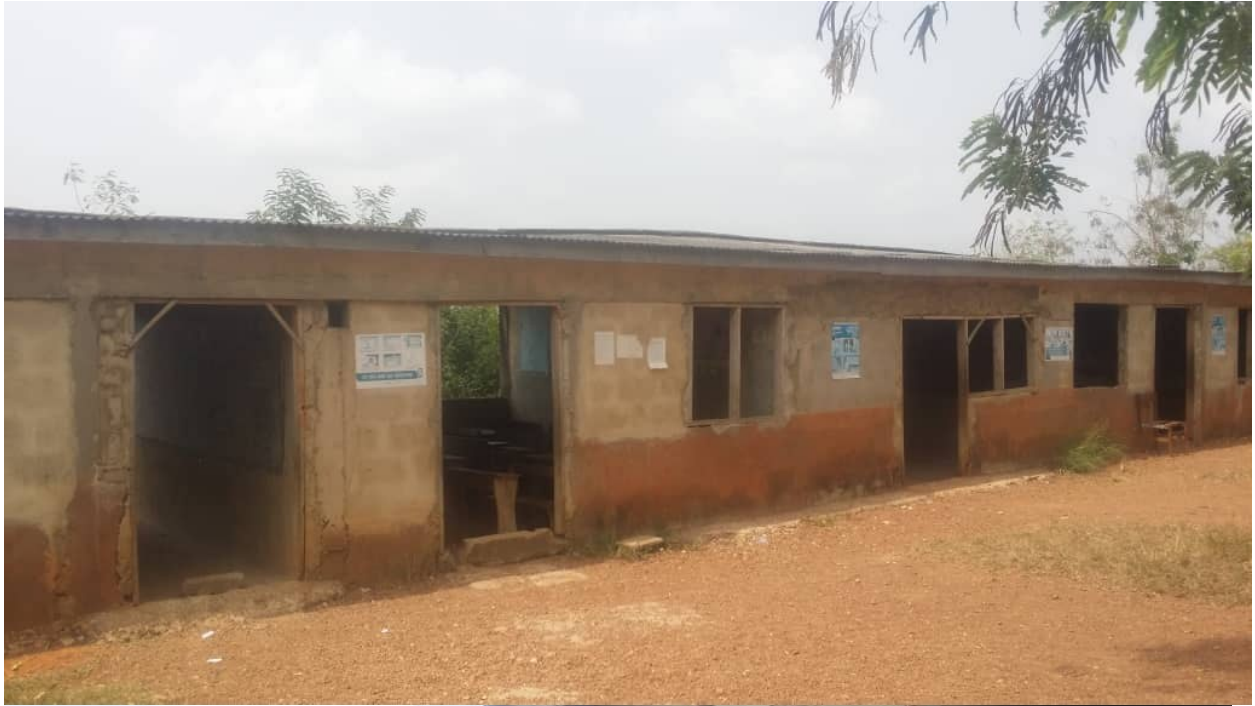
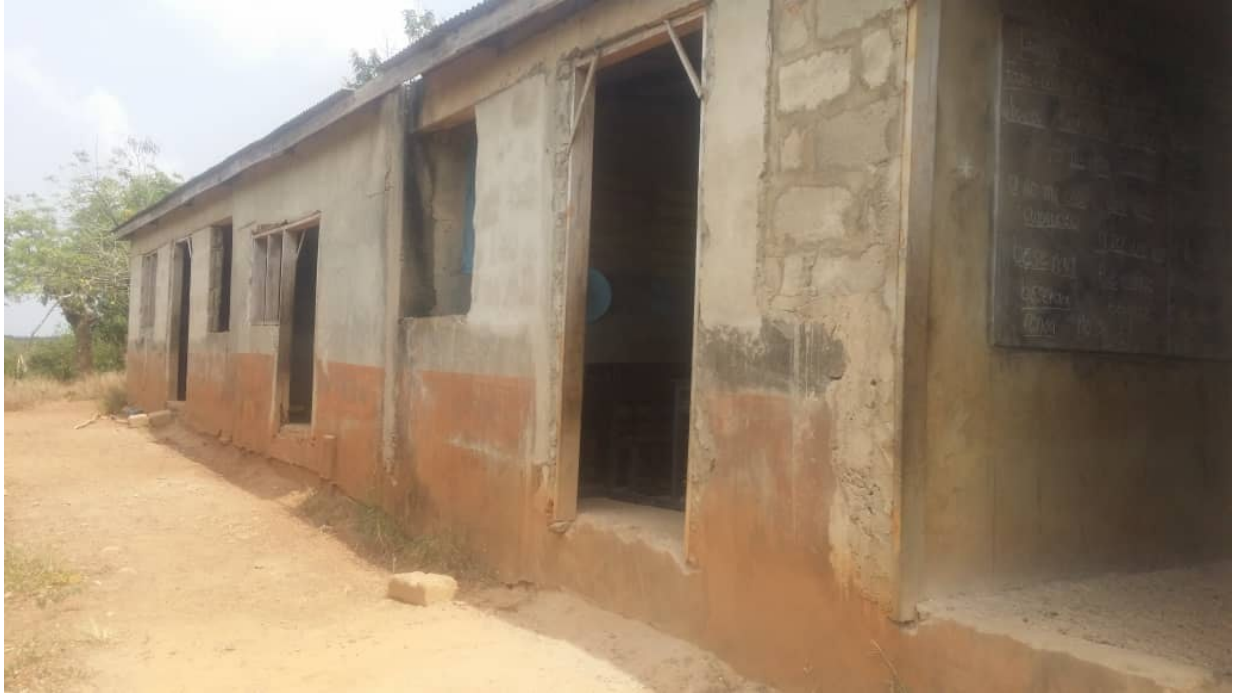
The classroom block (B) Above happens to be the Primary block of the Ekumfi, Atwea school, Which comprises of 3 three classrooms within this block. The floor of the entire block is below ground level, as the foundation of the block was not raised to the standard foundation level of our

building code specifications. This may cause Sand/debris within the classrooms, and also create floods within the classrooms

Furthermore the classrooms do not have ceilings within, as this may cause the roof to expel heat during the day time whilst the children may be in the classroom.

Window frames of the existing structure upon our assessment needs to be replaced due to its weak state.

Also some wooden roofing members need to be replaced as this is causing the roof to cave in, as this is extremely dangerous. Finally there are only doors and window frames, even not all as shown in the pictures and not a single door and window is being fixed.

This block happens to be the Primary section of the school. There is quite a no. of recommendations and an immediate attention must be paid to this structure. We recommend the following:
