Client: GZJMS charity.

Title of Project: Architectural Feasibility Study for the Renovation & Construction of the Existing Facility of the Ekumfi Atwea Primary & J.H.S School.

Location: Ekumfi Atwea, Mfantseman district, Central Region.

Consultants: Dez-intell Workstation (design, build, renovate, Landscape)

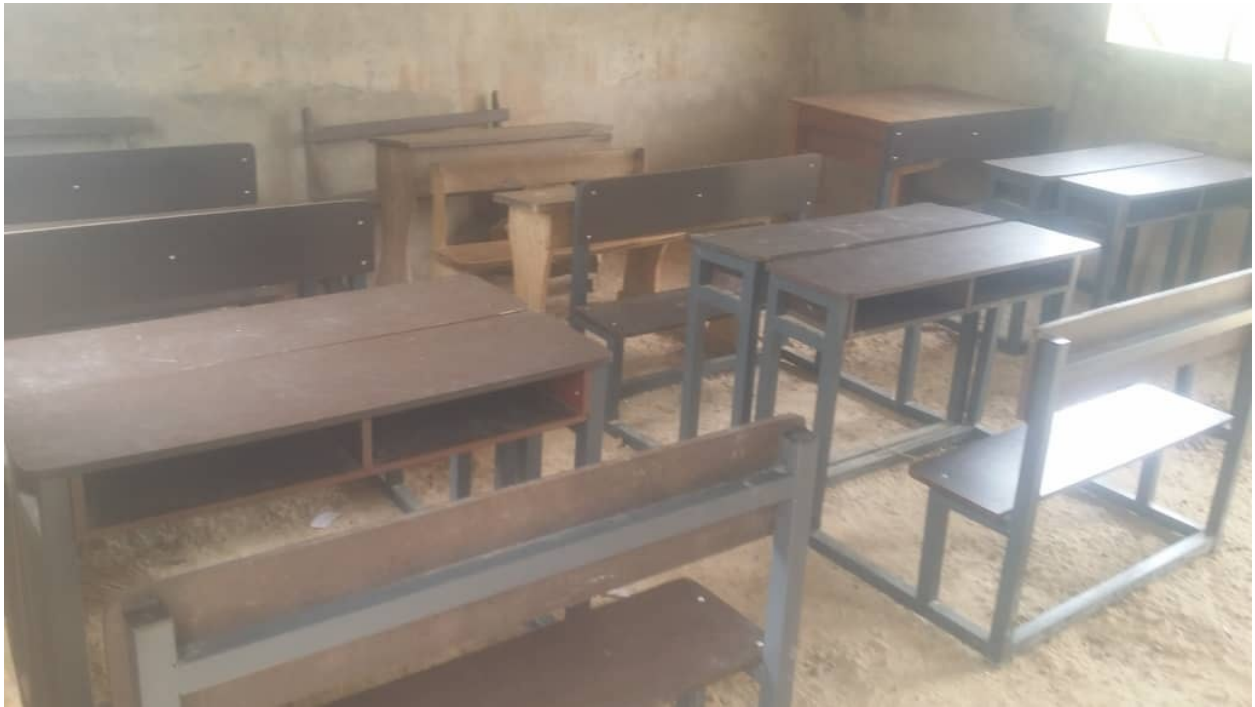
(Picture above shows some of the table and chairs being used by the school pupils)
